Evaluation of Tertiary Irrigation Canals' Lining Mutoubes District, Kafr El-Sheikh Governorate, Egypt

This study presents the results of investigation activities conducted at the reclaimed lands Project site in Mutoubes District, Kafr El-Sheikh Governorate, Egypt, in order to figure out the main causes of deterioration/damage of the existing tertiary canals (Mesqas) concrete linings. Detailed field investigation was performed, whilst all available technical documents on this project were studied. The testing program consisted of laboratory as well as field tests. Several boreholes were dug along the lined canals' embankment to cover the study area. Soil samples were collected from different depths at 30 cm intervals. All samples were tested for their chemical, physical, and mechanical properties. Irrigation water, drainage water, and groundwater samples were also collected and tested in the laboratory. On the other hand, the old lined mesqas were visually assessed. According to field observations and results of laboratory tests, the main causes of damage to the new lined mesqas were identified. The outcomes presented in this paper may be employed to propose an appropriate maintena

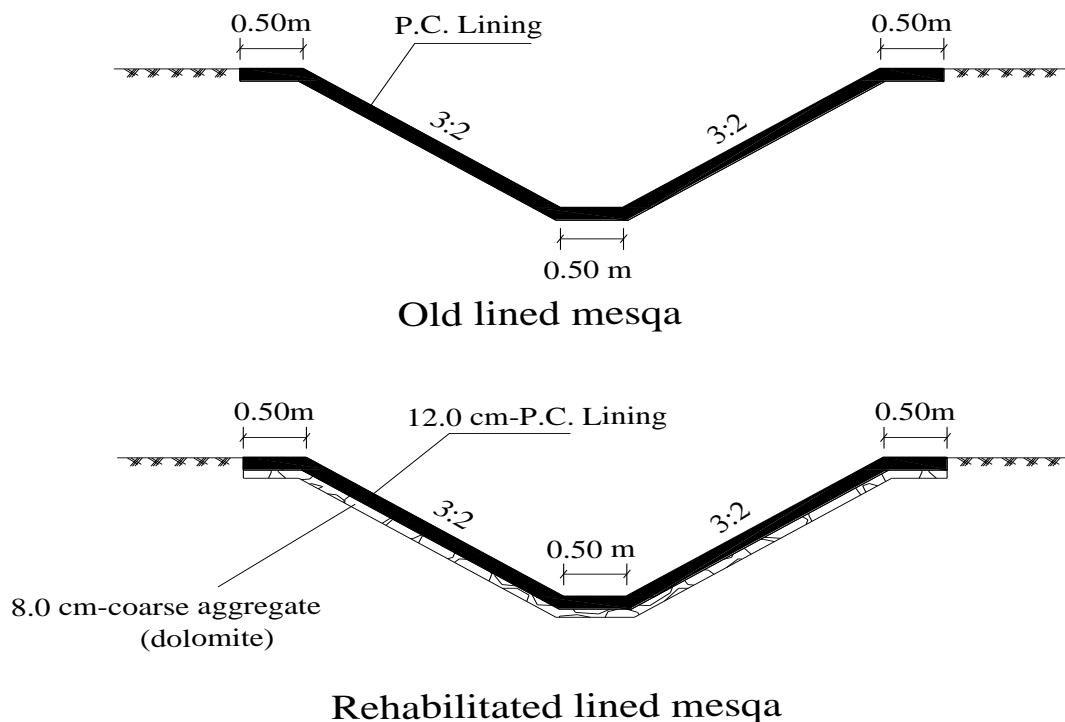
farmer officially receives water at the same time each week. Figure 4 shows a cross-section of old linedmesqas, Abdelhaleem (2018) (17 years in service).The cross-section of the recently rehabilitated lined mesqa is also depicted in Figure 4. The new lined mesqa, with a trapezoidal shape, bottom width of 0.5 m, side slopes of 3:2, depth of 1.5 m and length of about 1 km, was designed to carry a discharge of 0.07 m³ s⁻¹.The new unreinforced concrete lining has a thickness of 12 cm placed over a8cm subgrade of coarse aggregates (dolomite).

Figure4: Existing and rehabilitated lined cross-sections

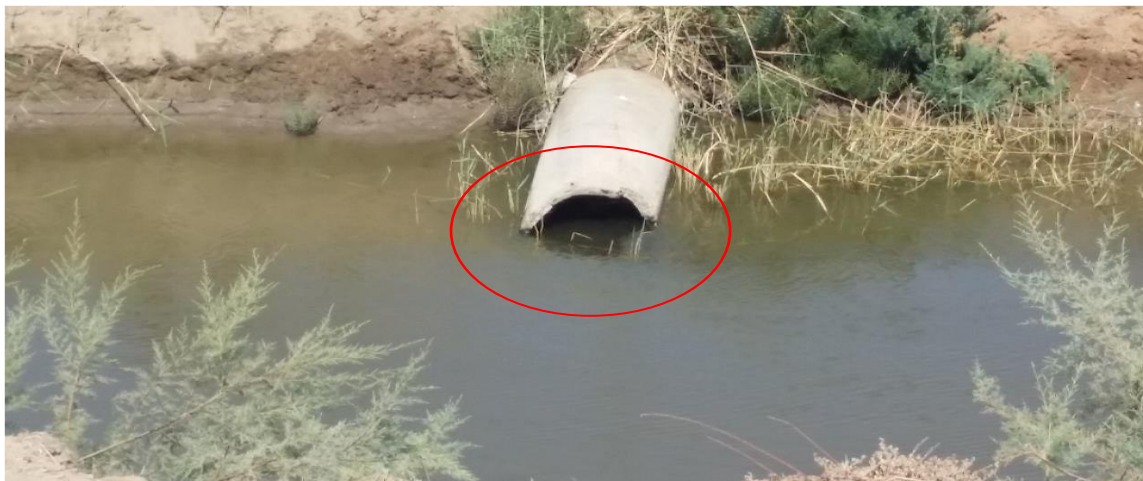
During the field program, it was observed that water levels were high in all drains. The water levels in drains were almost at the same elevations as those of water levels in mesqas. Most of the invert levels of tail escape pipes of mesqas were submerged in the drains' water (Clogged drainage), Figure 5. Grasses and shrubs were observed on the bottom and banks of all secondary drains. The bed levels of all drains were higher than the design ones. For the main drain (Moheet Zaghoul drain), leveling instrument was employed during the visit to measure the difference in water elevation between the main drain and El Brullus Lake at the location of the pump station. Based on measurements, the water levels in the main drain and in El Brullus Lake were (- 1.30 m+MSL) and (+ 0.30 m+MSL), respectively. This indicated that the operating static head of the pump station was 1.60 m, while the design one is 3.30 m, and hence the pump station operated out of the design condition. The field investigations revealed that the water level in the main drain was higher than the design one by about one meter. This implies that the dredging works of drains were not functional as only the banks were just cleansed.

Figure 5: Submerged pipe tail escape at a secondary drain

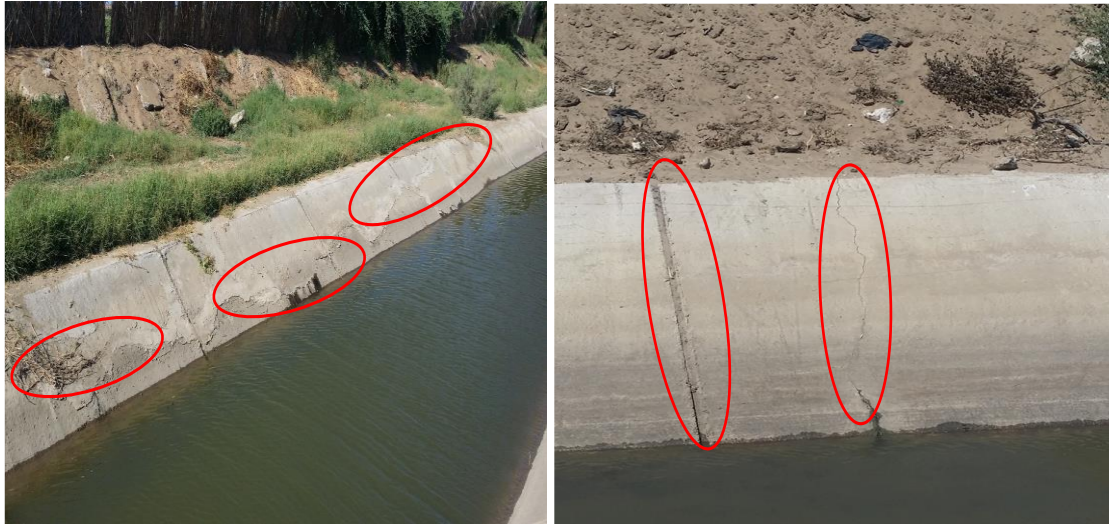
The new lined mesqas were damaged due to insufficient weight of the lining to resist the hydrostatic pressures and sub-erosion by piping under the lining slabs. For the recently rehabilitated lined mesqas (being in service for 2 years), it was noticed that transverse and longitudinal cracks appeared in some mesqas, Figure 6. The mastic filling of joints had completely disappeared or poorly repaired, resulting in open joints that allow the growth of wild grasses and piping erosion of the underlying soils across these joints, Figure 7.

Figure 6: Damages to the concrete lining

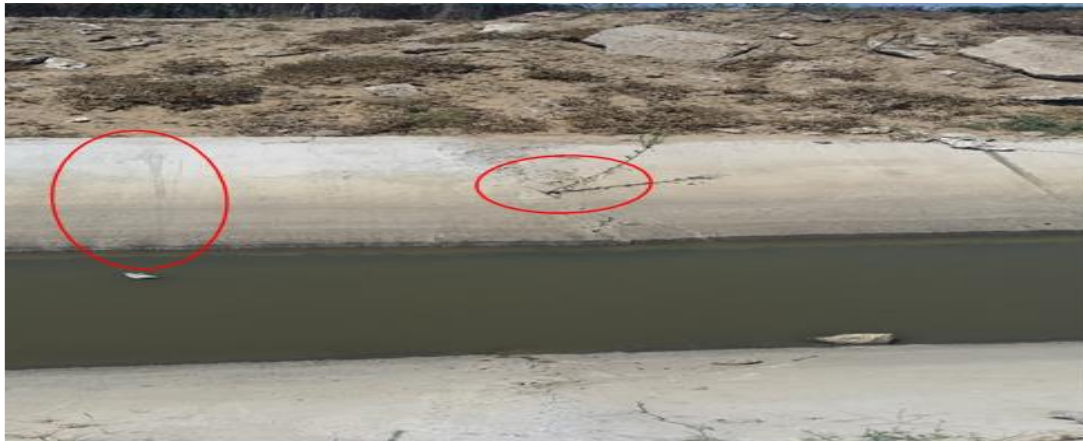
Figure 7: Growth of grasses at the concrete lining

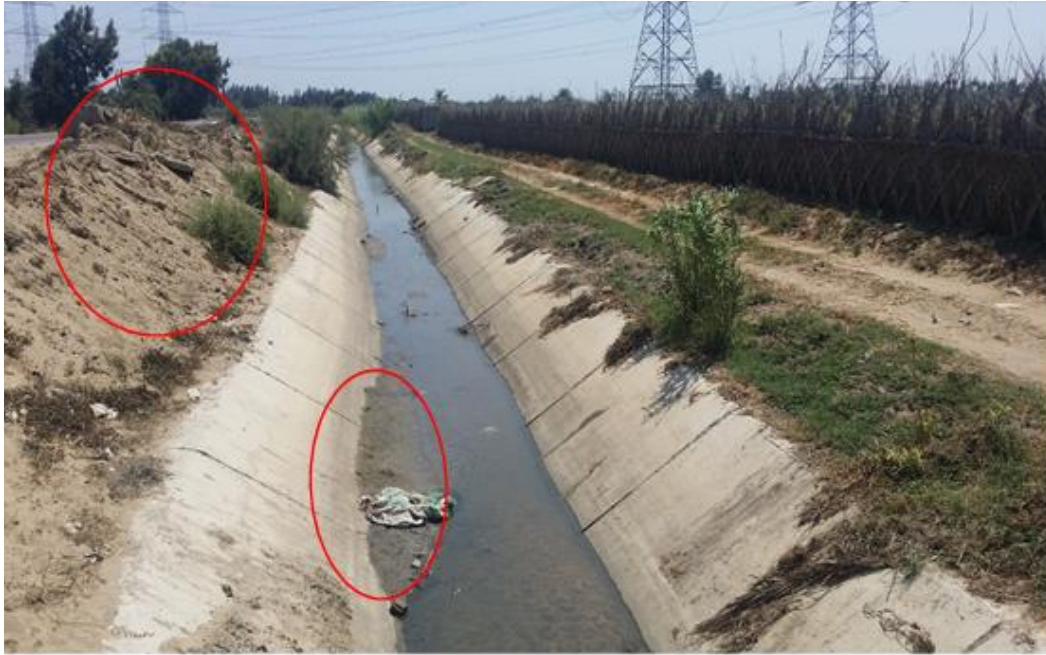
It was observed that most of reclaimed lands were at higher level by about 1.50 m than the irrigation mesqas, which led to sediment depositions in the mesqas due to the swirl winds (coastal nature). Damage was detected throughout mesqas length and at different locations. Most of these cracks occurred at places where mesqas constructed in cut embankment. The level of lands and flood irrigation contributed to the damage of lining due to the seepage line and nature of very loose soils, Figures 8-9.

Figure 8: Sediment depositions at lined mesqa

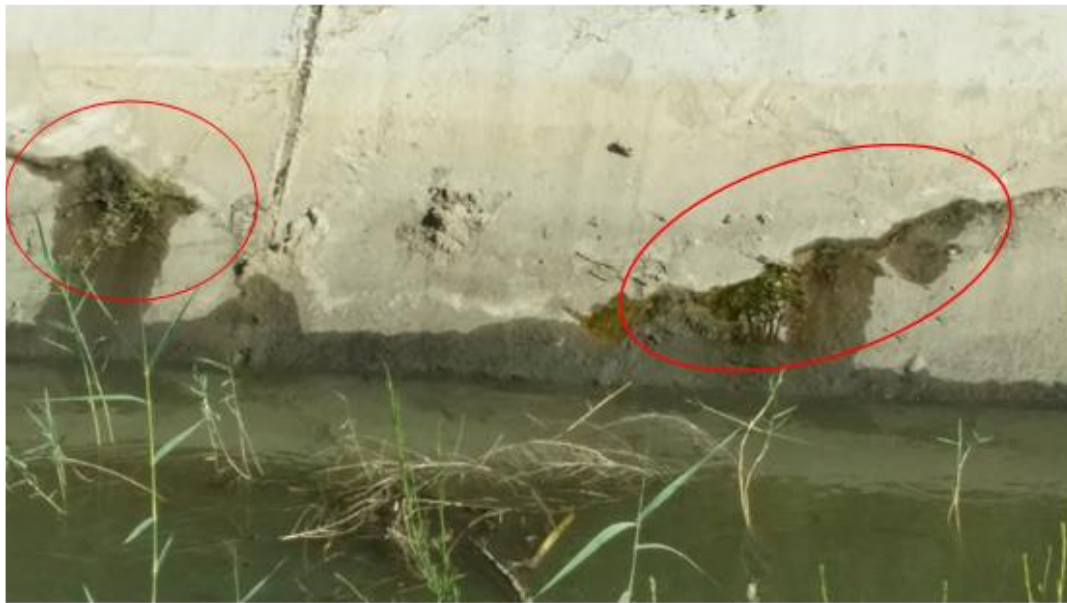
Figure 9: Seepage through the concrete lining

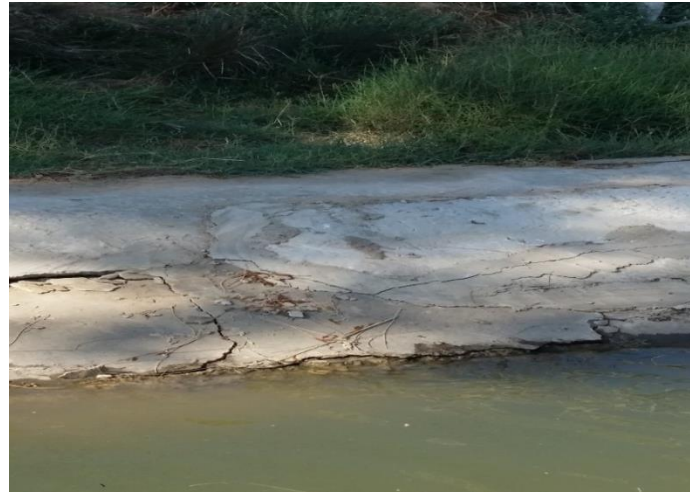
The dimension (top width and bed width), and side slopes of some lined mesqas (i.e. mesqa 24-25) are not complied with the design cross-section of the concrete lining. The field investigations indicated that the soil of the subgrade mostly consisted of unconsolidated sediments with fine/medium sand to sandy silt texture. The presence of fine particles of different sizes and quantity in the soil was an important feature of this region. The damage demonstrated in Figure 12 was attributed to the poor condition of the concrete lining (poor preparation) and piping erosion of the underlying fine soil. Although the thickness of the concrete lining of the design section is 12.0 cm, field observations revealed that concrete thickness of the collapsed panel is less than that, which is not sufficient to resist the hydrostatic pressure resulting from the groundwater table depth. The subgrade layer of 8 cm coarse aggregate was not observed under the collapsed panel. Meanwhile, farmers fractured the concrete lining in front of their farms

Figure 12: Sample of collapsed panels

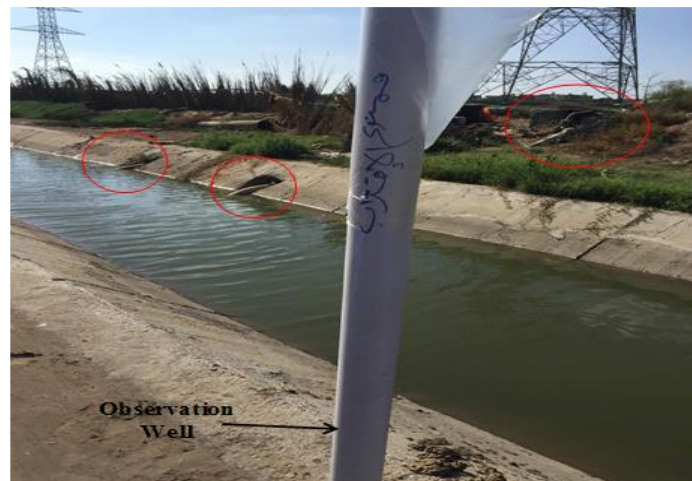
without technical supervision to lift the water to their reclaimed lands, Figure 13. Farmers also cultivate very close to the top of the lined mesqas. These actions from farmer's side contributed to the damage of concrete lining.

Figure 13: Lifting water by farmers
