## HYSTERETIC BEHAVIOR OF STEEL FIBER REINFORCED CONCRETE BRIDGE COLUMNS REPAIRED WITH EXTERNALLY BONDED CFRP

**Keywords:** Steel fibers; SFRC; Hysteretic behavior; Bridge columns; Ductility; Earthquake response; Quasi-static tests; Repair; CFRP.

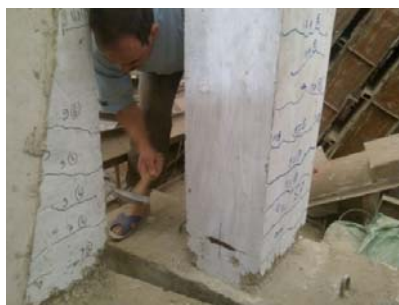
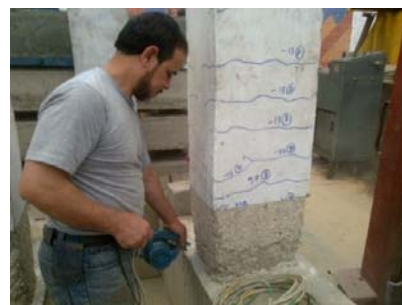
**Fig. 2:** Preparing of specimens, a) Removing loose concrete, b) Removing dust

The repair procedure followed the precautions stated in the Egyptian Code of Practice for the Use of Fiber Reinforced Polymer (FRP) in the Construction Fields <sup>[16]</sup>. First removing the damaged loose concrete using manual hammering, then use the compressed air to remove the dust, no water is allowed in the process. No ruptured steel reinforcement was found, therefore no need to add any extra reinforcement. Surface preparation or the sub base layer with rounded corners is used to compensate the damaged concrete. Sub base layer was made using Skiadur31CF and Sikadure501 Filler. The application process of the CFRP divided into two parts: Painting the surface with Skiadur330 epoxy resin, and then apply the longitudinal layer of the unidirectional CFRP Skiawrap230C. This longitudinal layer was applied to counteract the concrete transverse cracks at plastic hinge zone. This layer has L-shaped; 20cm glued to the column and 10 cm glued to the footing. For confining purposes, another layer of the Skiadur330 epoxy resin was painted and then transverse layer of the Skiawrap230C was wrapped. The wrapped layer width is 30cm which is equal to the length of the plastic hinge. Wrapping length is 150cm which is equal to the column perimeter in addition to 10 cm overlap required by the Egyptian Code of Practice for FRP. Finally, extra layer of Skiadur330 epoxy resin was painted to insure full saturation of the CFRP with epoxy. Fig. 4 illustrates the repair process. It is worthy to mention that the specimen S1, which did not contain steel fiber consumes double amount Skiadur31CF and Sikadure501 Filler compared to any other of the repaired specimens. This was due to big amount of damaged concrete as illustrated in Fig 3.

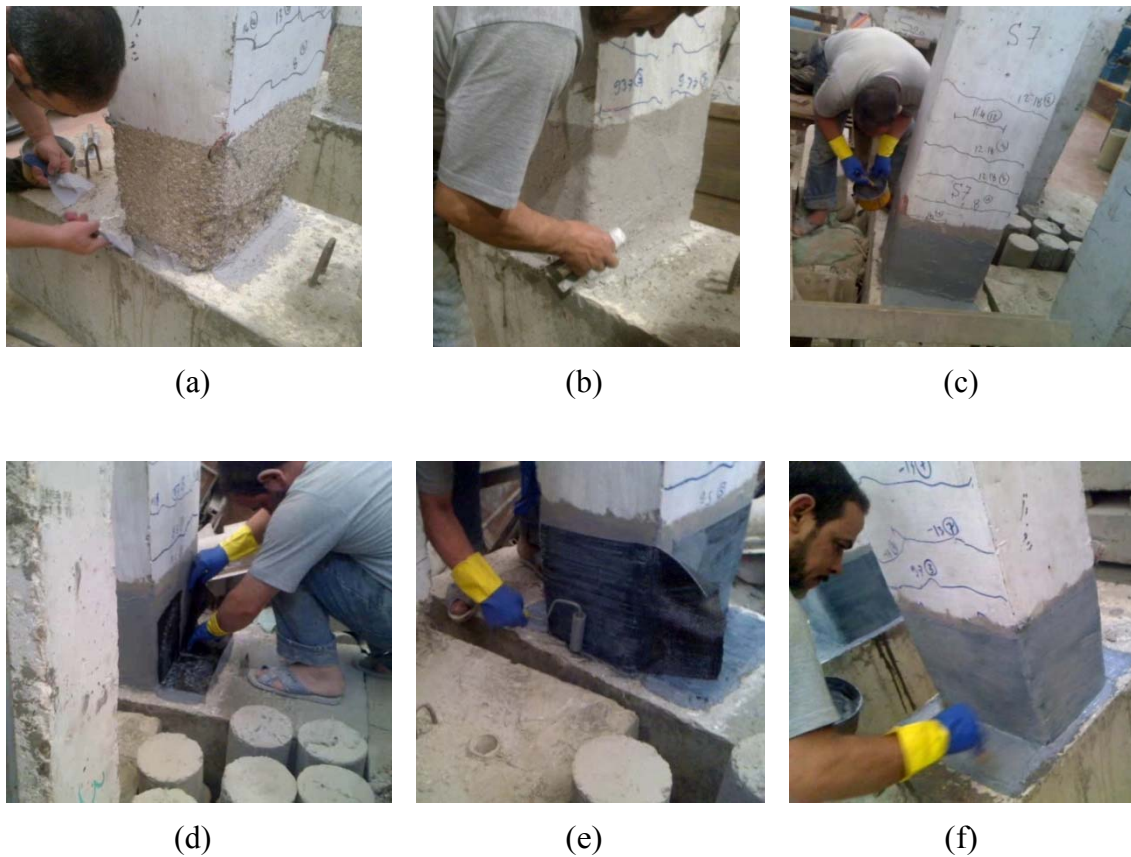
**Fig. 4:** Repair process, a) Application of Sikadure31CF, b) Rounded corners, c) Application of Skiadur330 d) Application of longitudinal Skiawrap230C e) Wrapping of transverse Skiawrap230C, f) Adding extra layer of Skiadur330

Sikadure501 Filler; which is a kind of quartz sand with mixing ratio 1:1. To counteract the formation of transverse cracks and to provide lateral confinement of the plastic hinge zone, longitudinal and transversal layers of Skiawrap230C were glued to the plastic hinge zone. It is a unidirectional woven carbon fiber fabric for the dry application purposes. Its nominal tensile strength is  $4300 \text{ N/mm}^2$ , its nominal elongation at break is 1.8%. It should be glued to the surface using Skiadur330 epoxy resin. It is two part epoxy based impregnating resin. Its initial setting time is 60 minutes at  $+23^\circ\text{C}$ . Dry application means that epoxy resin should be painted first, and then the dry CFRP applied next.

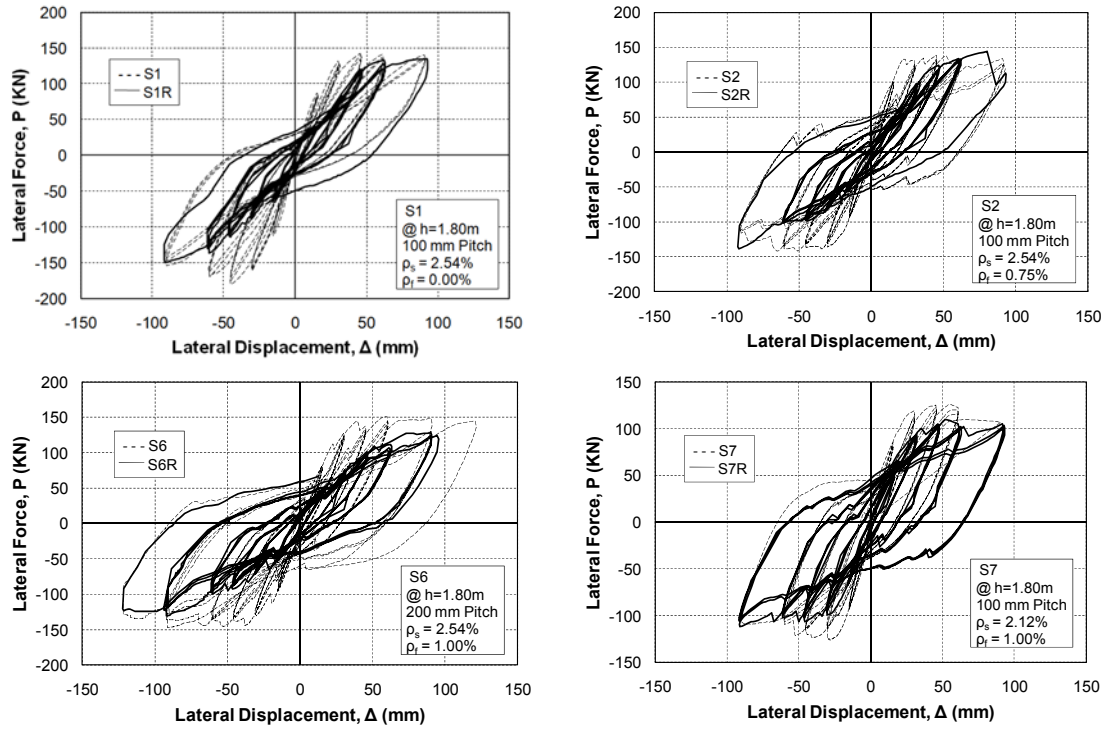
**Fig. 8:** Hysteresis loops for original and repaired specimens

The load-displacement hysteresis loops for both original and repaired specimens are illustrated in Fig. 8. It can be noticed that the repaired specimen behaved well and the hysteretic behavior was well recovered. The ultimate load was approximately recovered. The experimentally determined yield displacement was approximately doubled except for S7 it was about one and one half the original value. It is worthy to mention that for the first few cycles, the initial strength was not recovered due to previous yielding of the longitudinal reinforcement bars. Table 1 provides numerical comparison between some of the hysteretic indicators such as the ultimate load, the lateral displacement corresponding ultimate load, the failure displacement, and the yield displacement.

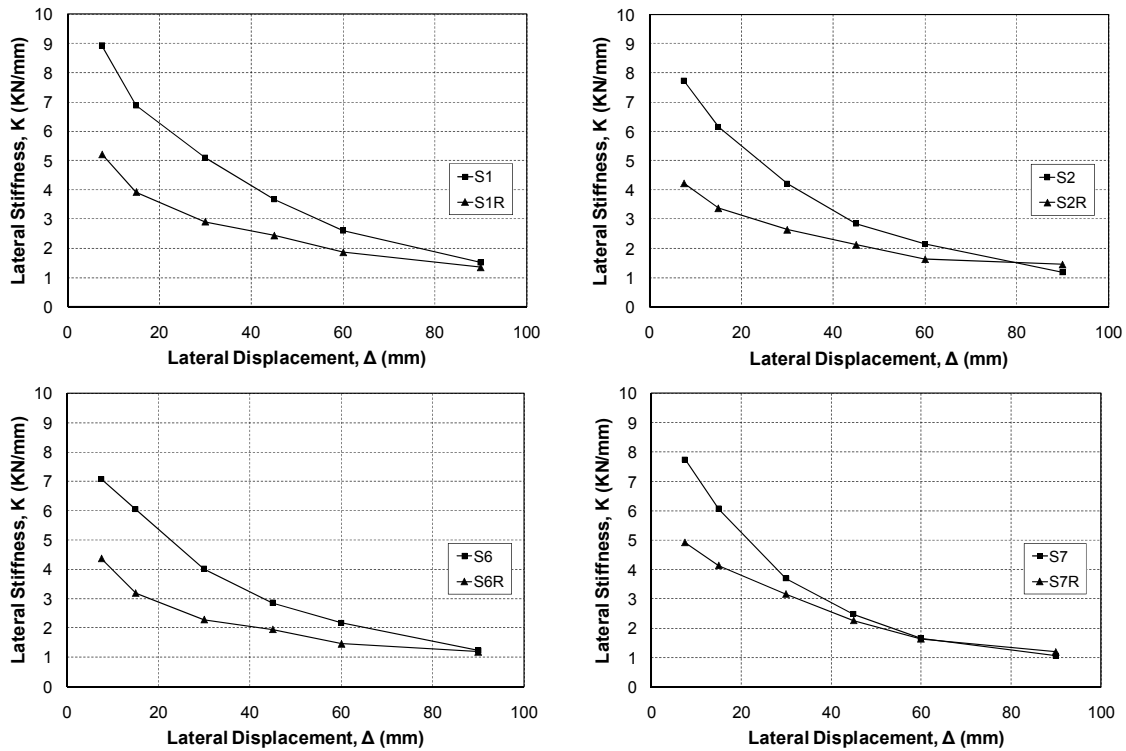
Fig. 11: Stiffness degradation of original and repaired specimens.

where:  $P_i$  is the maximum load at cycle  $i$ , and  $\Delta_i$  is the maximum displacement at cycle  $i$ . The cracked stiffness versus the lateral displacement to represent the stiffness degradation due to cyclic loading of the tested eight specimens is illustrated in Fig. 11 and table 5. It can be concluded that the stiffness was not completely recovered due to the previous yielding of the longitudinal reinforcement bars, but the gap decreased with the increase of the deformation level and with the increase of the steel fiber content.
