METHODS FOR REDUCING CONCRETE COVER DE-BONDING IN R.C. BEAMS STRENGTHENED IN FLEXURE WITH CFRP STRIPS

T. M. Elrakib

Ass. Prof., Housing and Building National Research Center, Cairo, Egypt

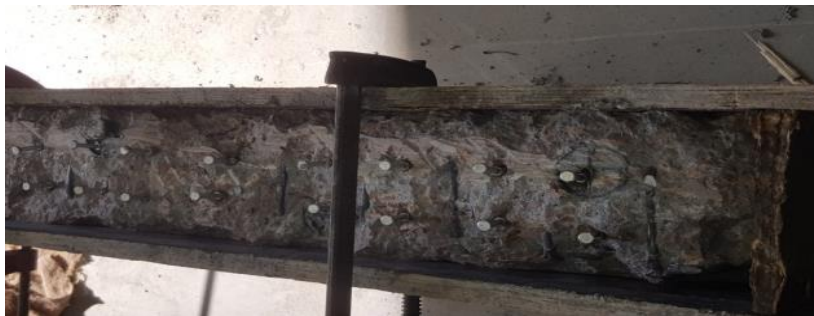
Fig.1: Studs in the old concrete before casting the new concrete cover of B5

strengthened in flexure using CFRP strip of width 100mm and externally bonded to the bottom of the beam using epoxy resin only without removal of the concrete cover and it was considered as control strengthened beam. The third specimen B3 was strengthened by CFRP strip after removing the concrete cover and recasting it using new concrete with compressive strength 20Mpa without any bonding technique between old and new concrete. The fourth beam B4 was similar to B3 but having bonding agent to bond the old and new concrete. In the fifth specimen, B5, steel studs of 6 mm diameter and 100 mm long were used as shear connectors between old and new concrete as shown in Fig.1. Half lengths of the studs were embedded in the old concrete. The studs were drilled in two rows with 100mm spacing between the stirrups.

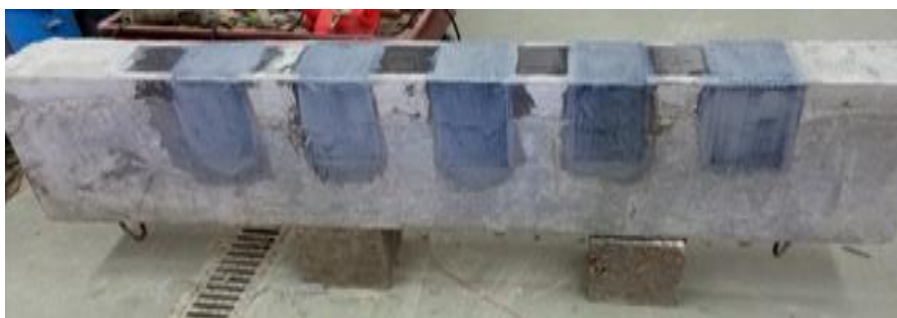
The sixth beam B6 was similar to B3 but extra CFRP sheets were used as U jacketing till the mid height of the beam cross section to bond the new concrete cover with the old concrete and also to bond the FRP strip. The U jacket is oriented to the mid height of the beam to avoid any effect on the shear capacity of the beam. The CFRP U jacket was of width 100 mm and spacing 100 mm as shown in Fig.2. For the seventh beam B7, a high strength concrete of 50 MPa was used for casting the new cover using silica fume admixture and a water reducing agent. Also, a bonding agent was used between the old concrete and the new concrete cover. The full details for all tested specimens are mentioned in Table 1.

Fig. 2: Strengthening configuration of B6

On the other hand, B6 which had the same aspects of B3 but U-jackets of CFRP sheets till the half of the depth were used. The failure mode of B6 showed de-bonding of the CFRP strip after rupture of the first CFRP U-jacket which represents a good

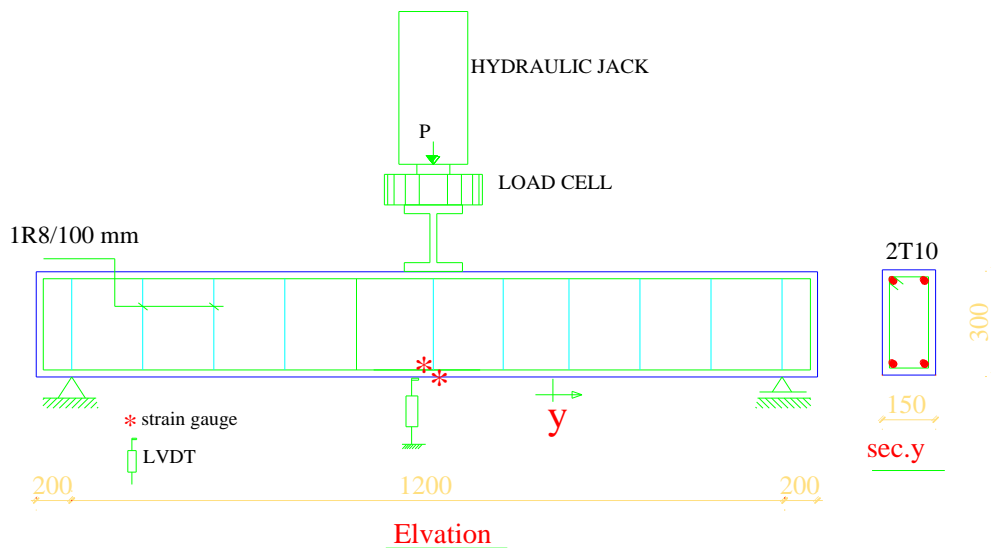
All specimens were tested under three point bending. The span of the beams was 1200 mm. Test specimens were instrumented to measure the applied load, mid-span deflection, and strains of longitudinal reinforcement. Strain gauges were mounted on lower reinforcement and on the CFRP strips. A general view of the instrumentation is shown in Fig.3. A linear variable displacement transducer (LVDT) for measuring deflection was mounted at the bottom side of the midspan for each specimen. Load was applied using a hydraulic jack of 2000 kN capacity in compression. The jack was equipped with a calibrated load cell of ± 1200 kN capacity to measure the applied load. During testing, the general deformational behavior was tracked. The development of cracks was marked along the sides of the specimens. At each load stage, the electrical strain gauges, load cells and (LVDT) voltages were fed into the data acquisition system. The voltage excitations were read, transformed and stored as micro strains, force, and displacement by means of a computer program that runs under the Lab View software.

Fig. 3: Test setup and instrumentation

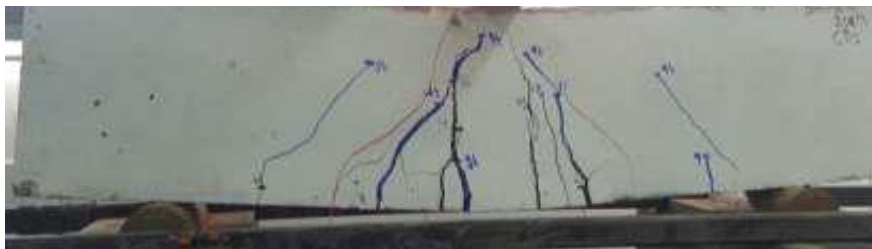
Fig. 4: Cracking pattern of control beam B1

As a result of this experimental work, two modes of failure were generally observed for the strengthened beams. Failure Mode I refers to the curtailment of the CFRP strip adjacent to the support originates a high concentration of stresses at the cut-off point of at the end of the strip. Failure Mode II refers to the concrete cover de-bonding starting from one of the intermediate flexural cracks towards the maximum bending moment zone. The horizontal crack is originated by splitting of concrete at the steel reinforcement level and mainly by shear stresses at that level which are needed to ensure equilibrium. On the other hand, the control beam B1 was loaded until complete failure. This beam started to crack at 50 kN, its ultimate load was 100 kN, the failure was due to flexural cracks followed by shear cracks as shown in Fig.4. The second control beam B2 was loaded till the cracking load then strengthened with one layer of CFRP strip and reloaded to failure. The crack load was 50 kN and the ultimate load was at 130 kN. Fig.5 clearly shows flexural mode of failure combined with de-bonding of the FRP strip with an increase in the ultimate load = 30% over the un-strengthened beam B1.

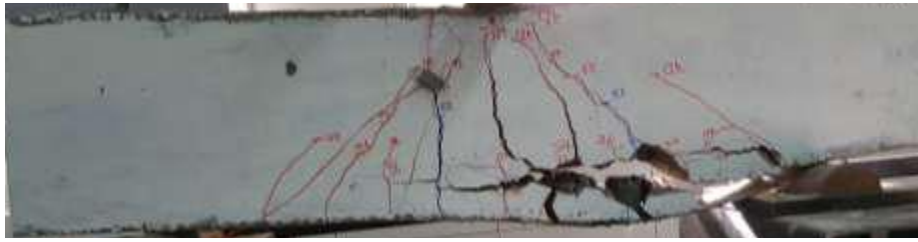
Fig.5: Cracking pattern of strengthened control beam B2

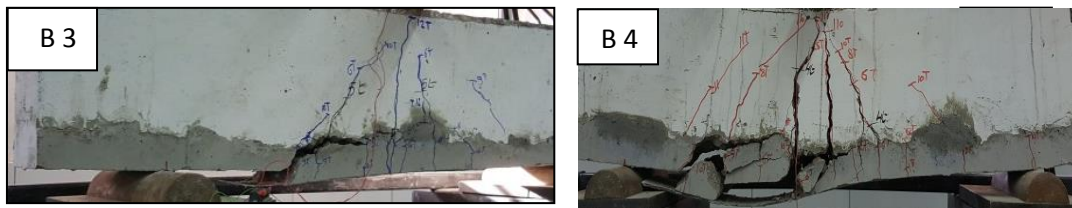
The Third beam B3 was loaded till the cracking load (50 kN) then the load was removed and a new concrete cover was recast without any bonding technique. The beam was strengthened with 1 layer of CFRP strip and reloaded up to failure. The ultimate load was at 110 kN. The failure mode showed concrete cover de-bonding followed by de-bonding of the CFRP strip with an increase in the ultimate load = 10% over the un-strengthened beam B1. The ultimate load decreased by 15% compared to the strengthened beam B2 that may be attributed to the early de-bonding of the new concrete cover. The fourth beam B4 having bonding agent between the old and new concrete cover had the same behavior and failure mode of B3. The ultimate load was 110 kN which indicates the using of the bonding agent had no significant effect on the load-deflection behavior or on the mode of failure, Fig. 6.

Fig.6: Cracking pattern of for strengthened beams B3& B4

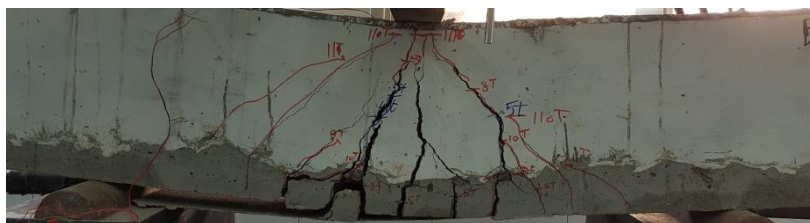
The fifth beam B5 was loaded to the crack load (50 kN) and then a new concrete cover was recast using shear connectors (steel studs 100 mm long and 6 mm diameter) then strengthened with 1 layer of CFRP strip and reloaded up to failure. B5 failed due to concrete cover delamination followed by de-bonding of the CFRP strip with ultimate load of 108 kN showing a little increase compared to the control beam B1, Fig.7.

Fig. 7: Cracking pattern for strengthened beam B5

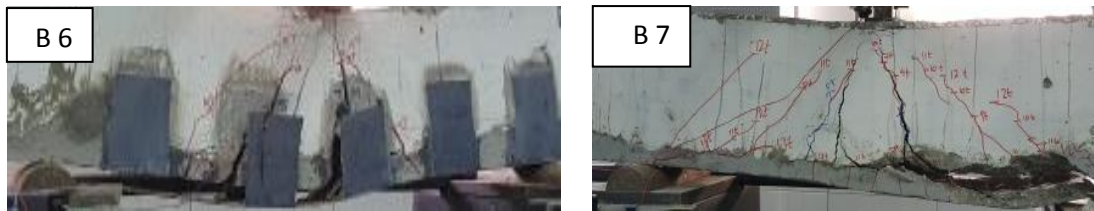
enhancement in the mode of failure. However, the ultimate load was 130 kN representing a good increase in the ultimate capacity compared to the control beam B1 and also it reached the same carrying capacity of the control strengthened beam B2. The seventh beam B7 had the same aspects of B3 but it had a high strength concrete for the new cover in addition to the use of bonding agent. The mode of failure showed flexural cracks followed by shear cracks then de-bonding of CFRP strip. The ultimate load was 150 kN representing the highest increase in the ultimate capacity compared to the control beam B1 and it exceeded the carrying capacity for the control strengthened beam B2 by 15%, Fig.8.

Fig. 8: Failure cracks for strengthened beams B6 & B7

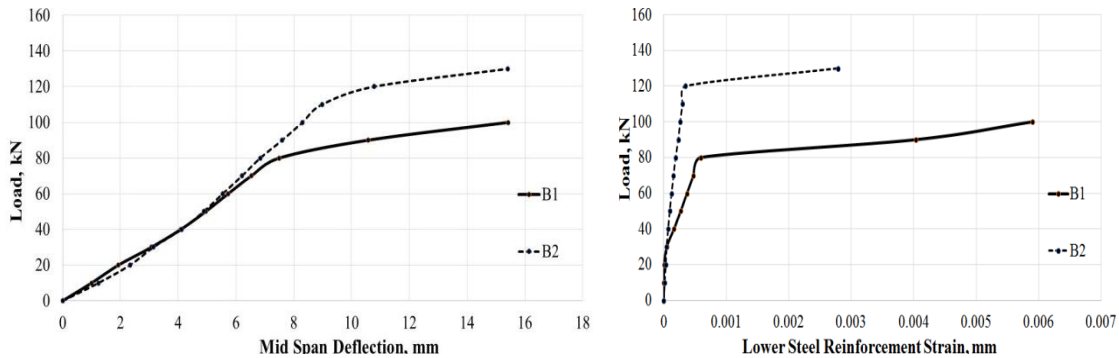
Comparing the load-deflection relationships of the un-strengthened beam B1 with the strengthened beam B2, it is noticed that both of them have same behavior till the cracking load then the strengthened beam B2 sustained more carrying loading capacity than the un-strengthened beam with decreasing in the mid-span deflection at the same loading level due to the restraining effect of the CFRP strip. On the other hand the strain in the longitudinal reinforcement exceeded the yielding strain for both beams. Also, the un-strengthened beam B1 sustained more strain for the longitudinal reinforcement than

the strengthened beam B2 at all loading levels, as shown in Fig. 9. Also it is clearly shown that the strengthening technique increased the ultimate loading capacity by 30%.

Fig. 9: Load vs. mid-span deflection and long. rft. strain for B1 & B2

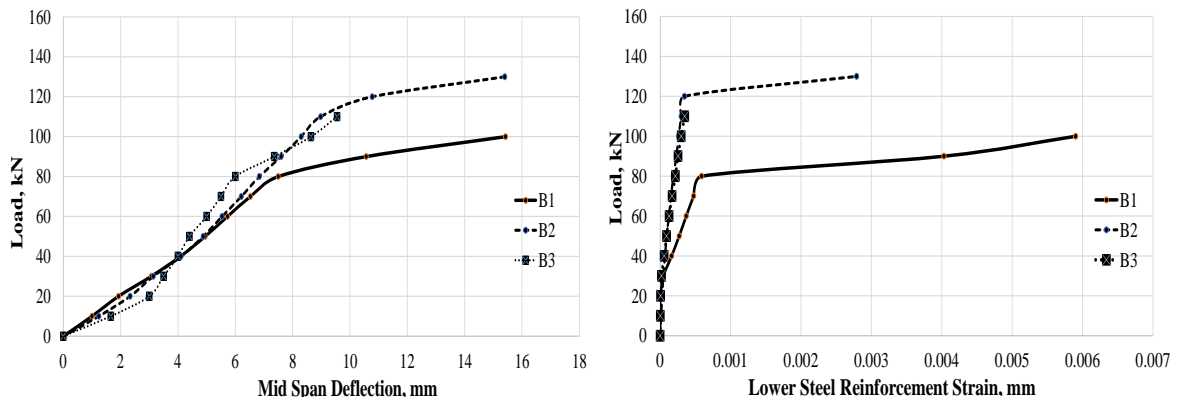
Fig.10 compares the behavior of the strengthened beam B2 with beam B3 that had a new concrete cover with no bonding technique. It is clearly noticed the effect of recasting a new concrete cover with lower compressive strength on decreasing the load capacity of the beam by 15% due to the early concrete cover de-bonding which affect the strengthening process. Also the repaired beam B3 did not reach the yielding strain for the lower reinforcement due to the sudden failure which related to the loss of bond between the weak concrete cover and steel reinforcement that led to decrease the beam ductility in spite of getting more load capacity compared with B1, Fig. 10.

Fig. 10: Load vs. mid-span deflection and long. rft. strain for B1,B2&B3

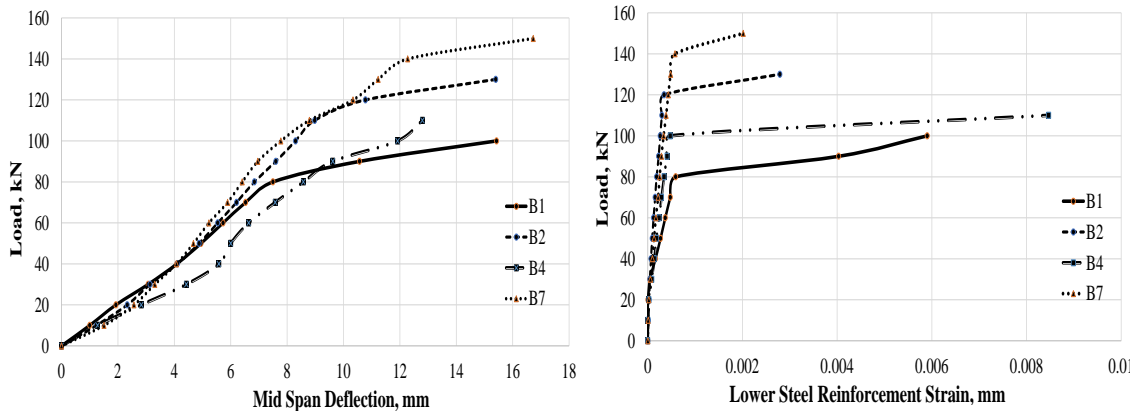
Fig. 11 shows the load- deflection relationship of beams B1, B2, B4, and B7. B4 had a new concrete cover with low compressive strength (20 MPa) and a bonding agent was used while B7 had same bonding agent with high compressive strength for the new concrete cover (50MPa). It is noticed that increasing the compressive strength is a very effective parameter as it enhanced the beam carrying capacity by about 40% over the

same beam with bonding agent to attach old and new concrete. Among the strengthened specimens, B7 recorded the highest value of ultimate load, 150kN. The ultimate load of the strengthened beams B4 and B7 were higher than that of the control beam B1 by 10% and 50% respectively. All beams reached the yielding strain of the lower reinforcement at the beam failure.

Fig. 11: Load vs. mid-span deflection and long. rft. strain for B1,B2,B4&B7

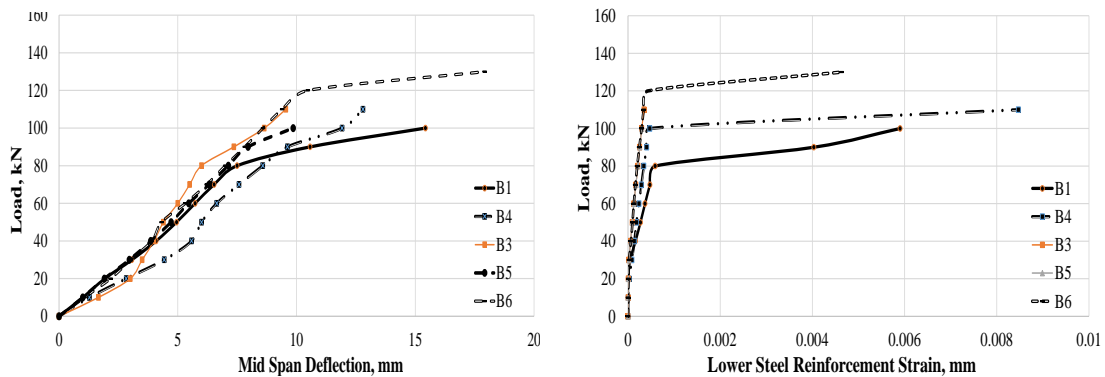
Fig. 12 shows the load deflection relationships for beams B1, B4, B3, B5, and B6. All these beams had different bonding methods to connect old concrete with the new concrete cover. B4 had bonding agent, B5 had steel shear connectors while B6 had CFRP sheets as U- jacket. It was noticed that the U- jacket of CFRP sheets had superior behavior which led to the same ultimate load capacity of B2 (strengthened without removing the concrete cover). This indicates that the CFRP U- jackets had dual effect for not only bonding the new concrete cover with old concrete but also bonding the CFRP strips with the old concrete of the repaired beam leading to a more ductile behavior. On the other hand both beams B4 and B5 which strengthened by CFRP strips did not show a significant enhancement in the beam ultimate capacity and failed with a brittle mode of failure. This indicates that bonding new weak concrete cover using shear connectors or bonding agent was insufficient. All beams lower steel reinforcement exceeded yielding point before failure except C3 and C5.

Fig.12: Load vs. mid-span deflection and long. rft. strain for B1, B3, B4,B5&B6
