Rate of Reinforcement Corrosion in Two-Span Loaded and Unloaded Reinforced Concrete Beams

O.A. Hodhod¹, A.M. Sanad², M.M. El-Attar¹, H.A. Hassan³

This paper investigates the rate of corrosion of reinforcement in two-span reinforced concrete beams. A comparison between testing a corroded unloaded beam and loaded beams is presented. Twenty-two reinforced concrete beams were designed, casted, and subjected to accelerated corrosion using the impressed current technique. Beams were divided into three groups: one loaded under own weight only, the second initially loaded till 40% of the ultimate load, and the third loaded till 60% of the ultimate load. Results are presented in terms of voltage readings versus duration for each beam. Results showed the great influence of initially loading the beams on the rate of corrosion initiation and propagation.

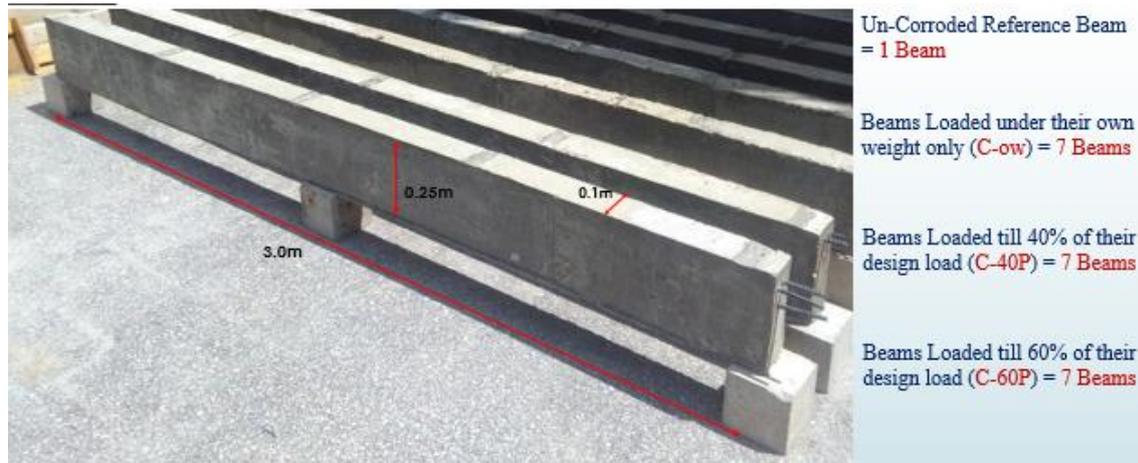
Figure 1: Typical beam dimensions

This paper is a part of a complete study investigating the effect of reinforcement corrosion on mechanical behavior of loaded and unloaded two-span reinforced concrete beams at various degrees of corrosion. The study includes a total of 22 beams: one control beam (non-corroded control beam, NC-CB) and 21 beams divided into three groups with 7 beams per group. The first group is corroded while unloaded (loaded under own-weight only, C-ow), the second is corroded after subjected to a load equals to 40% of the ultimate load specified after testing the NC-CB beam (C-40P), and the third group corroded after loaded till 60% of the ultimate load (C-60P). Beams dimensions are: 100 mm width, 250 mm height, and 3000 mm total length divided into two equal spans as shown in Fig. 1.

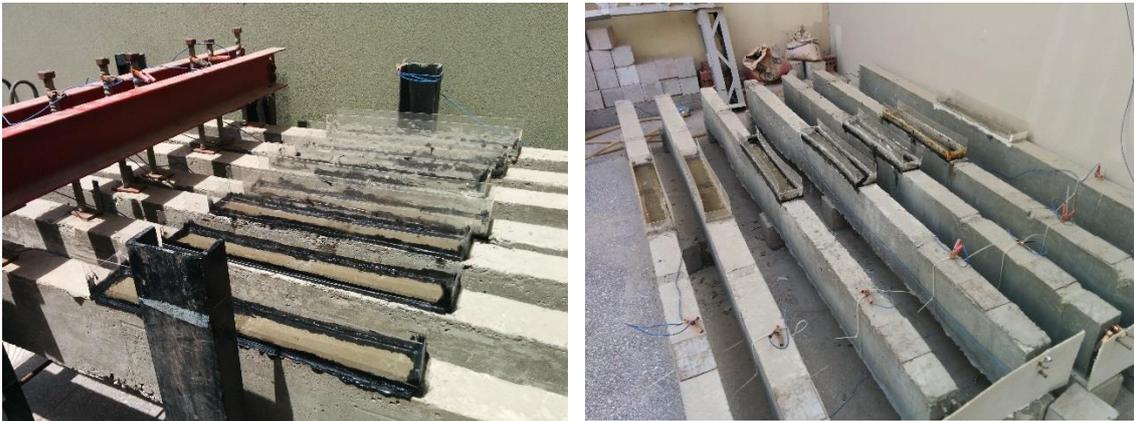
Figure 3: Acrylic ponds fixed at the selected sections and filled with 5% NaCl

The selected face to be corroded was at the middle upper face of the beam, where the maximum moment occurs. This is the section of the largest cracks' widths and therefore is more vulnerable to chloride ingress more than other sections. For contaminating the selected face only, an acrylic pond was fixed on the upper face of the beam at the selected section as shown in Fig. 3. This pond was filled with 5% NaCl solution during the wetting period (4 days) and was left empty during the drying period (3 days).
