Study of Bond between Near-Surface Mounted Bars and frp strips and masonry

Samar I Mubarak¹, Tarek El-Salakawy², Gehan Hamdy³, Mohamed Osama R. Al-Hariri⁴

¹Graduate Student, ²Assistant Professor, ³ Professor, ⁴Professor
Faculty of Engineering at Shoubra, Benha University,

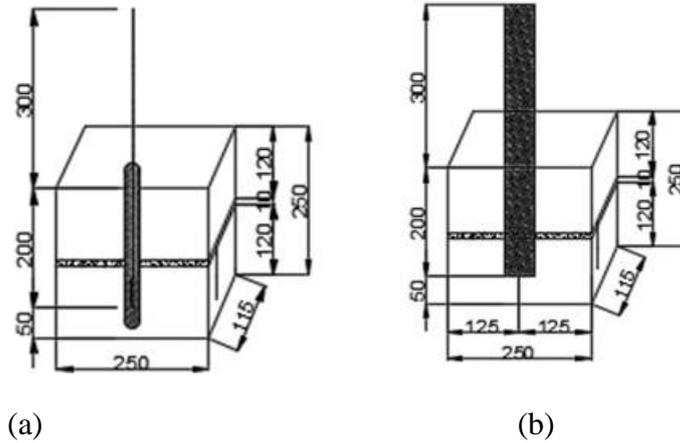
Fig.1. specimens shape and dimensions,(a) specimen with steel bar,(b) specimen with frp

Pull-out test was carried out for 24 prism specimens. Prism specimen consists of two block units (250x115x120) bonded together with mortar layer with mix proportion 1:3 according to Egyptian code of practice [1]. prisms were prepared and cured for three weeks. specimens shapes and dimensions are as shown in Fig.1. specimens are such as:

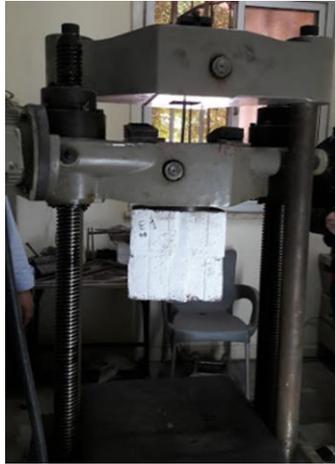
Fig.2. pull-out test set-up

The reinforcement is attached to the upper fixed part of the machine and the prism is attached to the under movable part of the machine. When applying loads; the reinforcement will be under tension load. failure load has been recorded , elongation ,cracks and the mode of failure . test setup is shown in Fig.2.

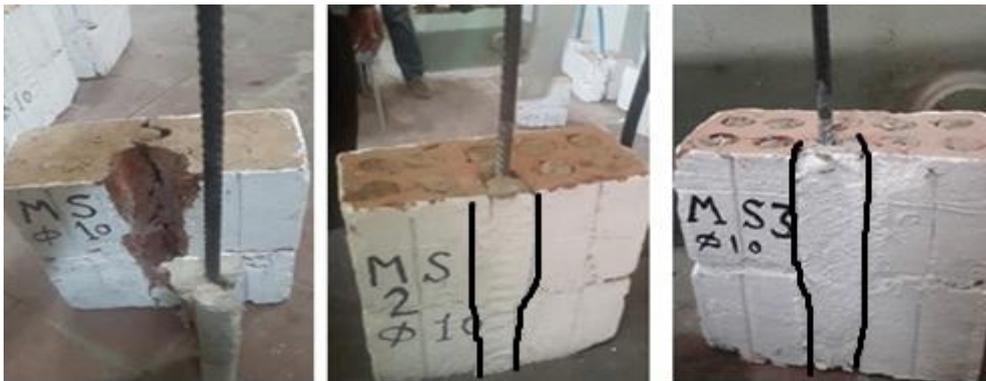
Fig.3. mode of failure of specimens with steel bar 10mm embedded in mortar

The failure loads for the three specimens MS1#10, MS2#10, and MS3#10 are 8.1, 16.5 and 19.55kN, respectively, with an average value of 14.71kN for the three specimens. The failure modes for two specimens MS2#10, MS3#10 is splitting of bars from mortar and de-bonding between mortar and masonry, and specimen MS1#10 is de-bonding between mortar and masonry led to taking off the bar with the mortar from the groove as shown in fig.3.

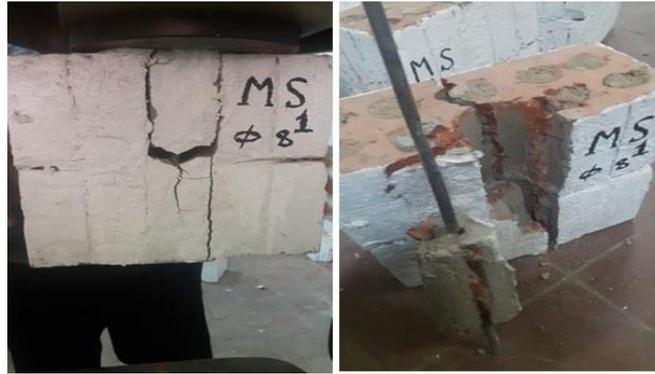
Fig.4. mode of failure of specimens with steel bar 8mm embedded in mortar

The failure loads for the three specimens MS1#8, MS2#8, and MS3 #8 are 11.5, 12.5 and 15kN, respectively, with an average value of 13kN for the three specimens. The failure modes for two specimen MS1#8, MS2#8 is de-bonding between mortar and the specimens led to taking off the mortar with the bar from the groove, elongation for the bar by distance equal 10cm and fracture of the prism as shown in Fig.4.

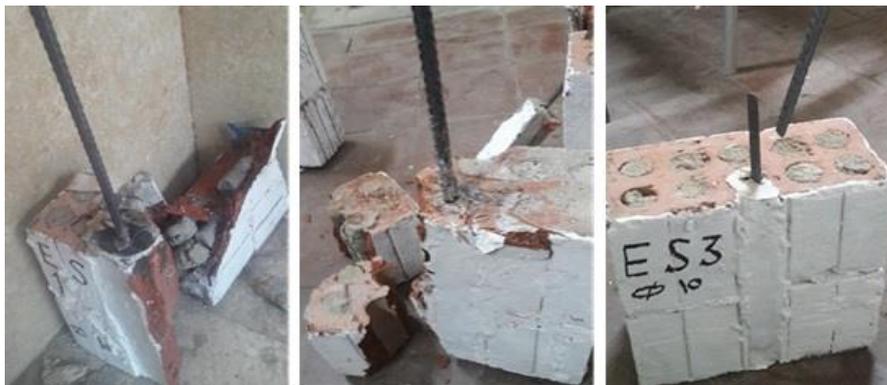
Fig.5. mode of failure of specimens with steel bar 10mm embedded in epoxy

The failure loads for the three specimens ES1#10, ES2#10, and ES3 #10 are 48.20, 44.85 and 50.50kN, respectively, with an average value of 47.85kN for the three specimens. The failure modes for all three specimens no failure for the epoxy with the bars but the failure happened to the block such as specimens ES1 & ES2 or rupture of bar only such as ES3, as shown in Fig.5.

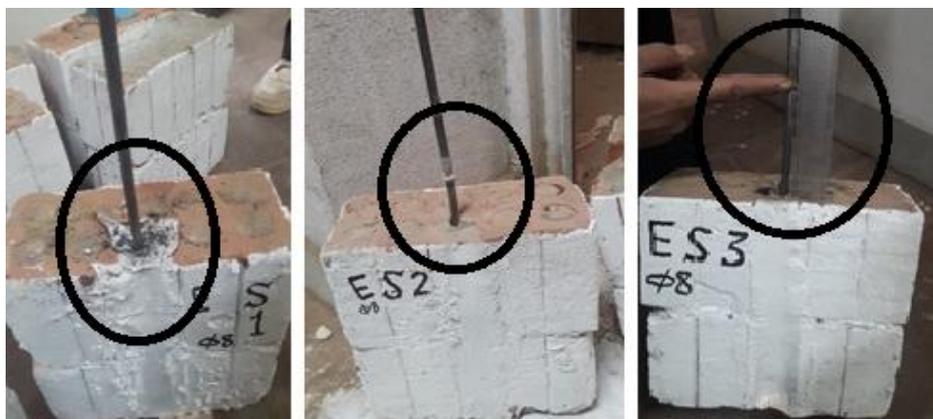
Fig.6. mode of failure of specimens with steel bar 8mm embedded in epoxy

The failure loads for the three specimens ES1#8, ES2#8, ES3#8 are 20.85, 22 and 21.15kN, respectively, with an average value of 21.33kN for the three specimens. The failure modes for all three specimens are splitting of the bar from epoxy as shown in Fig.6.

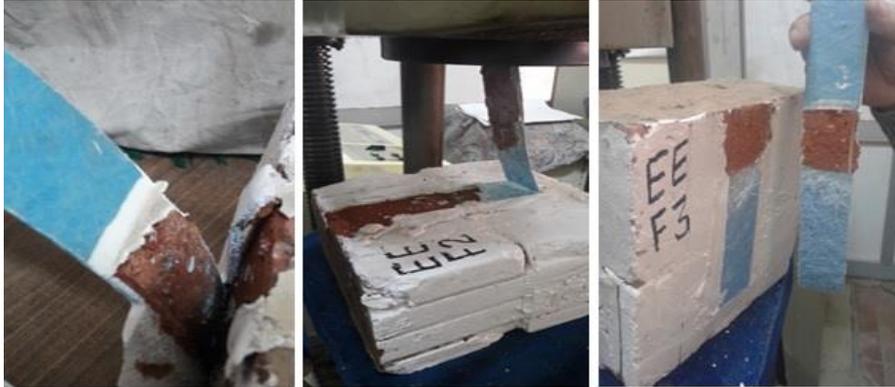
Fig.7. mode of failure of specimens with GFRP bonded externally

The experimental results for three specimens of GFRP strips of width 50mm externally bonded with grout are as follow: The failure loads for the three specimens EEF1, EEF2, EEF3 are 1.25, 0.46 and 0.52kN, respectively, with an average value of 0.743kN for the three specimens. The failure modes for all three specimens are failure of the interface between the GFRP strips and masonry as shown in Fig.7.

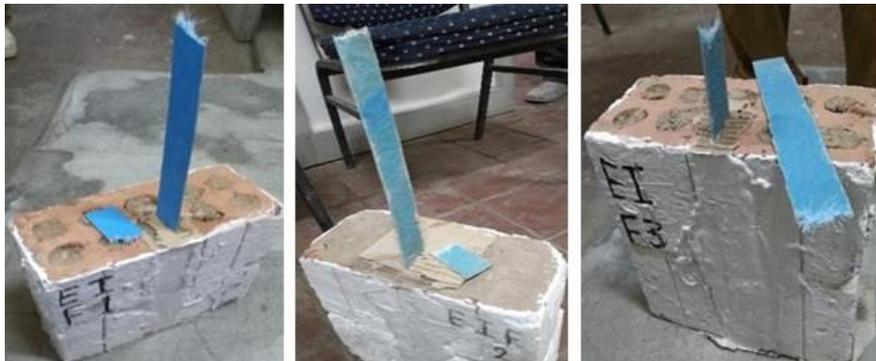
Fig.8. mode of failure of specimens with GFRP NSM

The experimental results for three specimens of GFRP strips of width 35mm inside epoxy are as follow: The failure loads for the three specimens EIF1, EIF2, EIF3 are 2.90, 2.43 and 4.02kN, respectively, with an average value of 3.11kN for the three specimens. The failure modes for all three specimens are rupture of GFRP strips as shown in Fig.8.

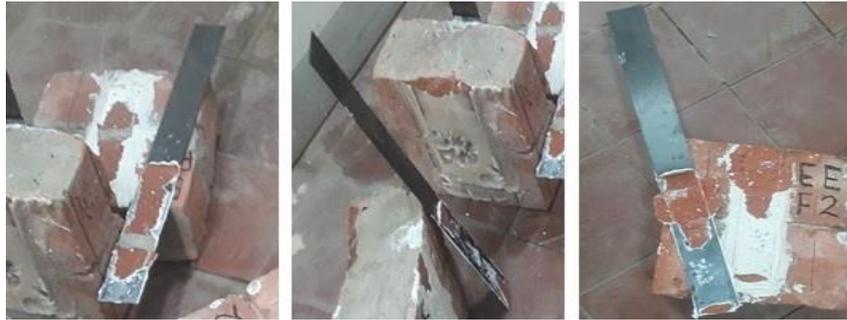
Fig.9. mode of failure of specimens with CFRP bonded externally

The experimental results for three specimens of CFRP strips of width 50mm externally bonded with adhesion material are as follow: The failure loads for the three specimens EEF1, EEF2, EEF3 are 1.11, 2 and 2.73kN, respectively, with an average value of 1.95kN for the three specimens. The failure modes for all three specimens is de-bonding the CFRP strips with the adhesion material and apart of the surface of the blocks as shown in Fig.9.

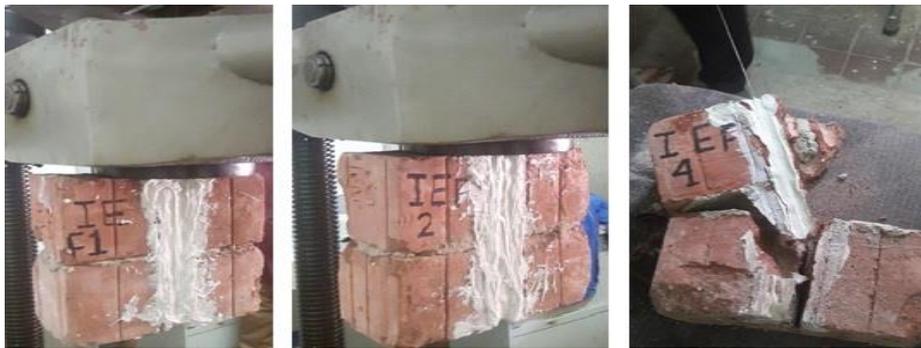
Fig.10. mode of failure of specimens with CFRP NSM

The experimental results for three specimens of CFRP strips of width 35mm inside epoxy are as follow: The failure loads for the three specimens EIF1, EIF2, EIF3 are 2.56, 2.22 and 2.8kN, respectively, with an average value of 2.52kN for the three specimens. the first two specimens didn't show any deformation or failure however the last one the prism broken without any failure or deformation for the fiber or the adhesion material as shown in Fig.10.

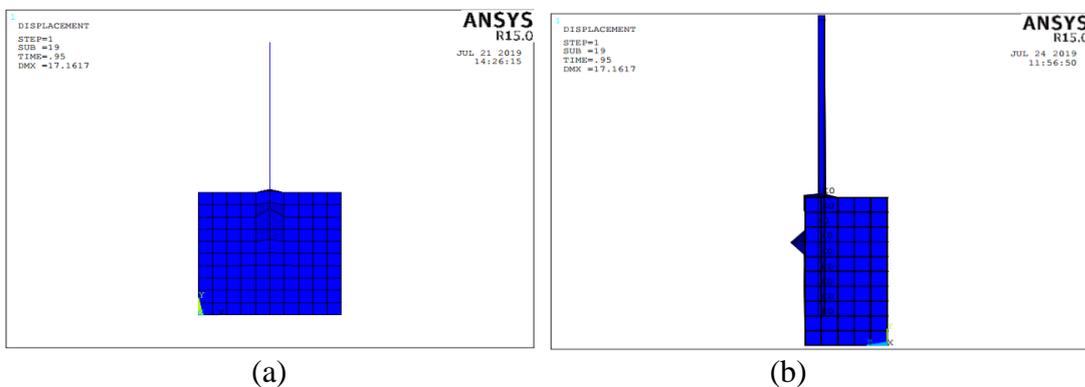
Fig.11. deformed shape

failure load is determined and recorded 18.57kn. results of the model are presented as follow: deformed shape, stresses, crack pattern and load-displacement curve as shown in fig.11 to fig.15.

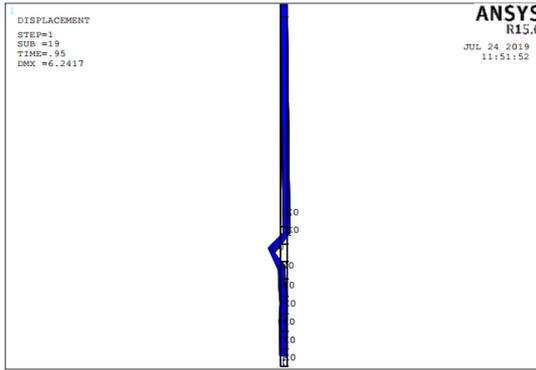
Fig.12. deformed shape of bar

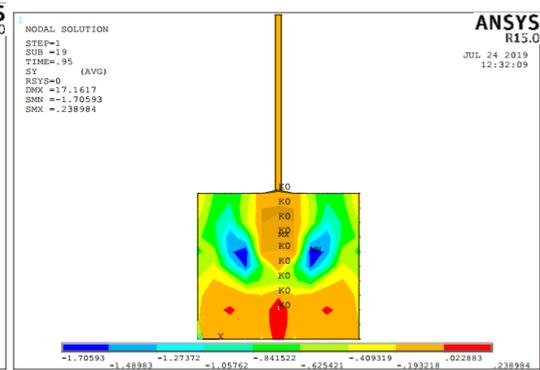
Fig.13. stresses of specimen

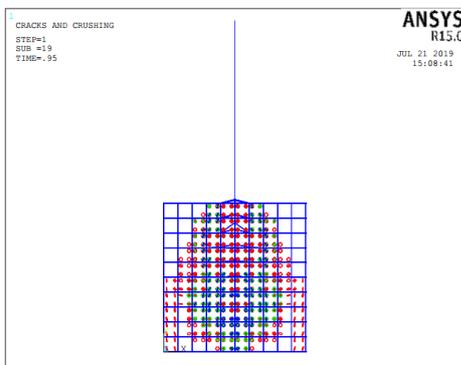
Fig.14. crack pattern

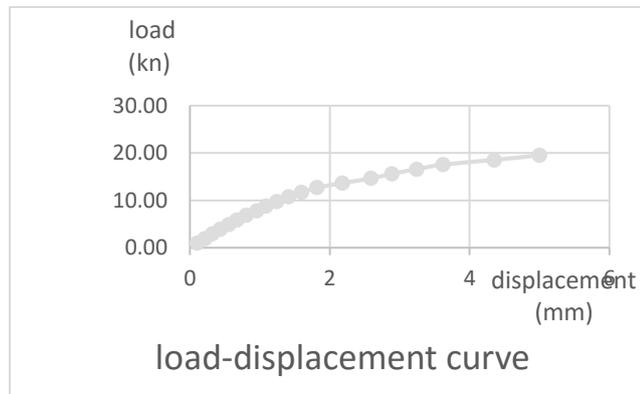
Fig.15. load-displacement curve

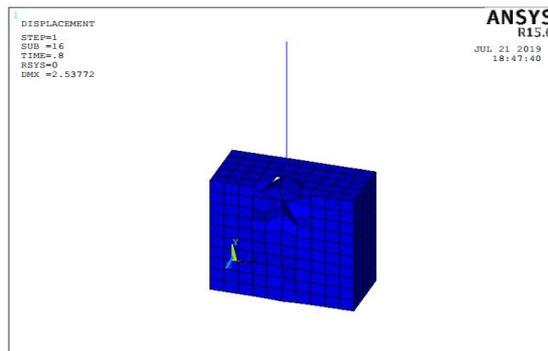
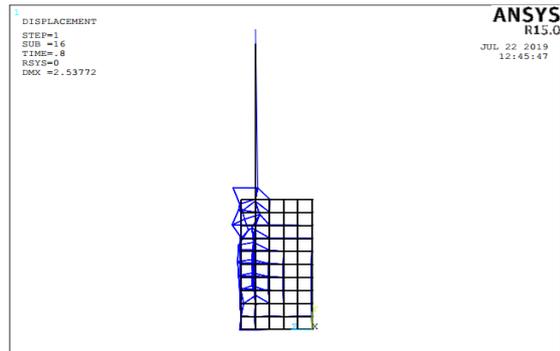
Fig.16. deformed shape

failure load is determined and recorded 50kn. results of the model are presented as follow: deformed shape, stresses, crack pattern and load-displacement curve as shown in fig.16 to fig.20.

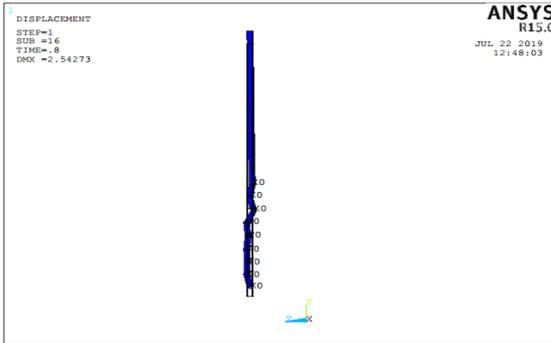
Fig.17. deformed shape of bar

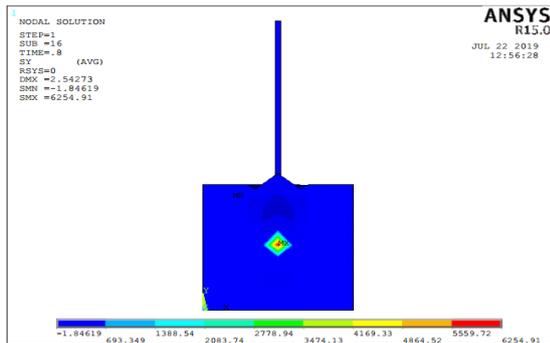
Fig.18. stresses of specimen

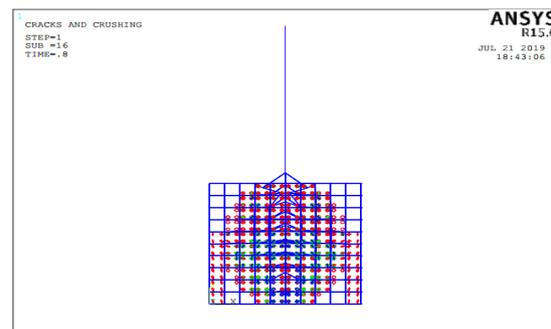
Fig.19. crack pattern

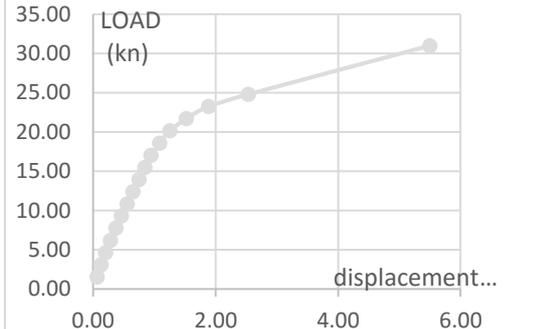
Fig.20. load-displacement curve

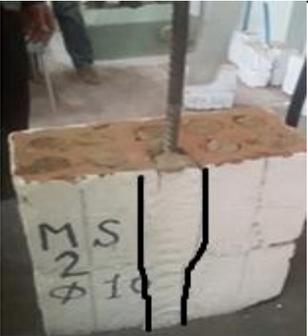
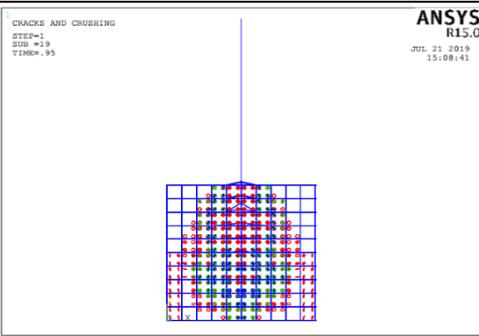
experimental	numerical
Failure load	14.71kN	18.57kn.
Failure mode of specimen

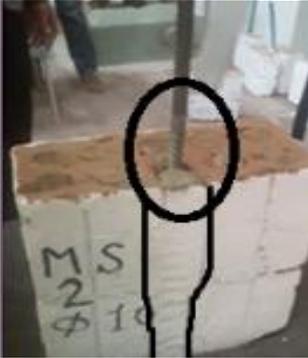
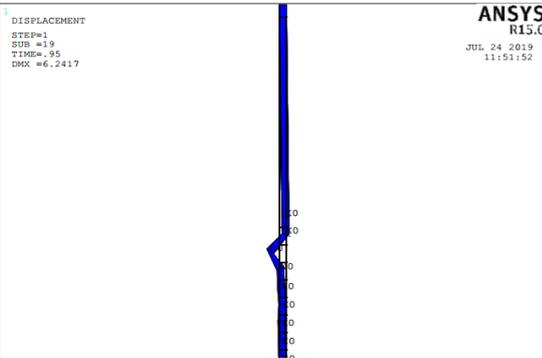
Failure mode of bar

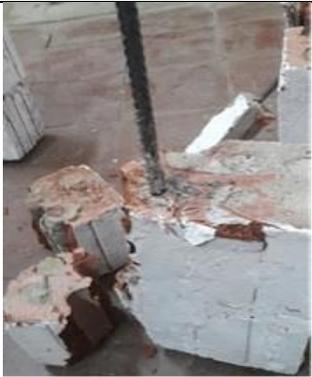
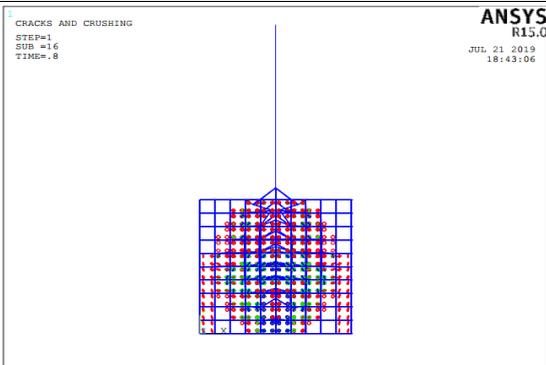
experimental	numerical
Failure load	47.85kN	50kn
Failure mod of specimen

Full bond case could be achieved experimentally and numerically in case of epoxy with steel bar of dia.10mm. as epoxy has high strength comparing with mortar and high tensile steel (rough surface) affected on increasing the load capacity. numerical approach is in agree with experimental results.

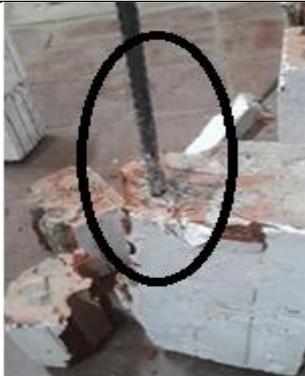
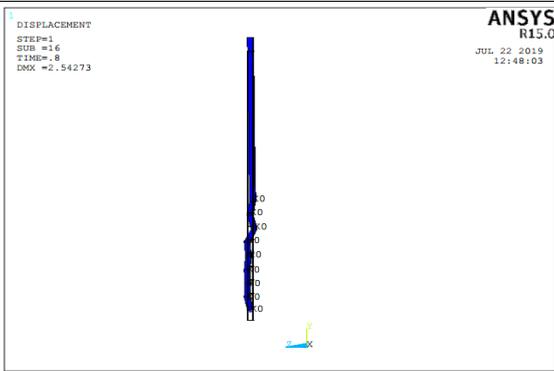
Failure mod of bar
