## Behavior of Reinforced Concrete Beams Exposed to Fire with Adding Basalt Fibres to the Mix

Eng. Mostafa Salah\*, Dr. Nasr Z. Hassan\*\* and Dr. Hala Mamdouh\*\*\*

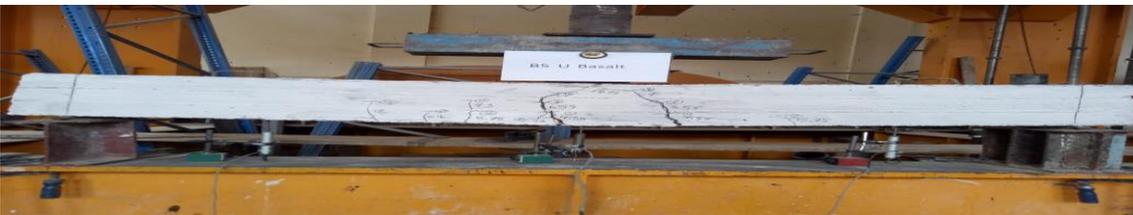
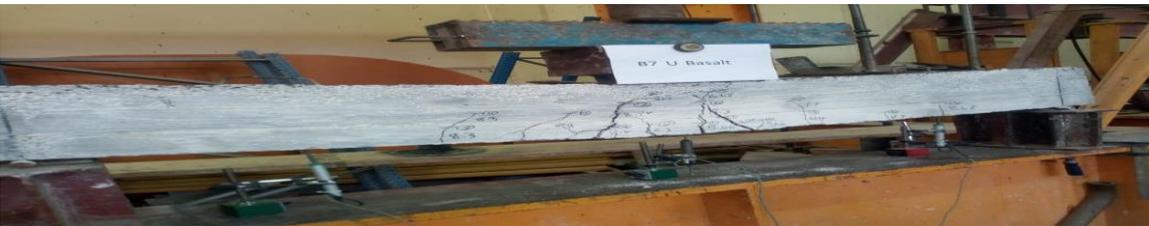
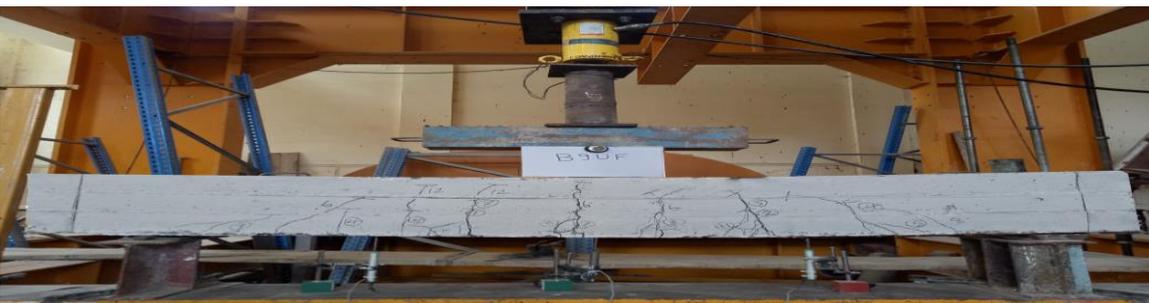
Cracks begin to occur with one crack in the middle of beam (B3UB) with the first drop in strain bar reading otherwise the cracks is to start with one crack in the middle of beam (B3UB) but without drop in bar strain. Number of cracks had done in beam B3UB is more than beam B1UF. There is a different between two beams in shape of cracks at the end of loading at failure, beam (B1UF) had shape of one crack in the middle between two bows but beam (B3UB) had two cracks from the bottom connected to each other in the middle to be one crack at the end of the beam and Cracks with smaller crack width were observed) due to the effect of basalt fibers in bonding the cracks. The crack pattern for beams (B1UF and B9UF). begin to occur with two cracks in the middle of beam then started to widen and extend until connected to each other and failure occurred. Number of cracks had done in beam (B9UF) is more than beam (B1UF). There is different between two beams in shape of cracks at the end of loading at failure; beam (B1UF) had shape of one crack in the middle between two bows but beam (B9UF) had a three main cracks in the middle with a clearance distance widen and extended together until the middle crack had a large widen before a failure, shear cracks observed in beam (B9UF) in order to the beam designed to flexural failure this must because the effect of fire on concrete . The crack patterns for beams (B5UB and B7UB) begin to occur with two cracks in the middle of beam then started to widen and extend until connected to each other and failure occurred. Number of cracks had done in beam (B3UB) is more than beams (B5UB and B7UB) and number of cracks in beam (B7UB) is more than (B5UB). There is a different between 3 beams in shape of cracks at the end of loading at failure; beam (B3UB) had two cracks from the bottom connected to each other in the middle to be one crack at the end of the beam but beam (B5UB) had a two main cracks in the middle with a clearance distance widen and extended together until connected to each other just before failure and beam (B7UB) had a three main cracks which in the middle third of the beam the first two cracks connected to each other in the middle of beam line but the third still alone extending in diagonal shape to the other and the two cracks extended and widen together but the failure occurred from the first crack as shown in Fig (6,7,8,9 and 10).

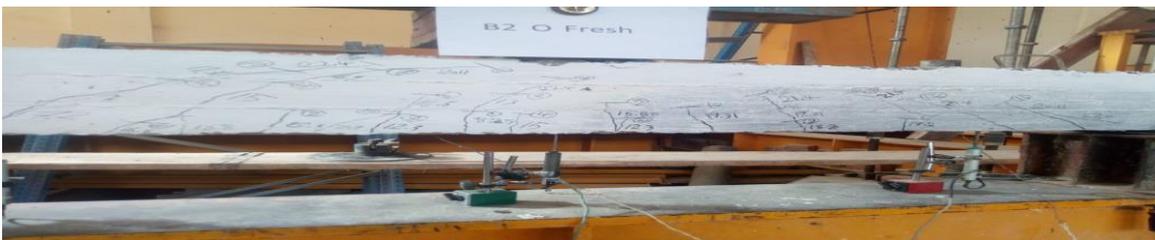
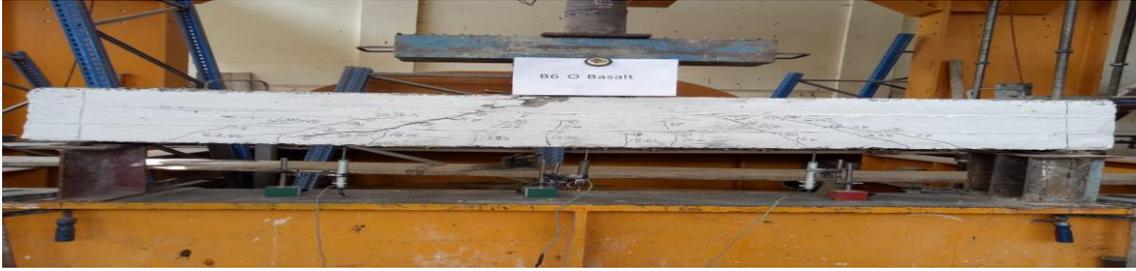
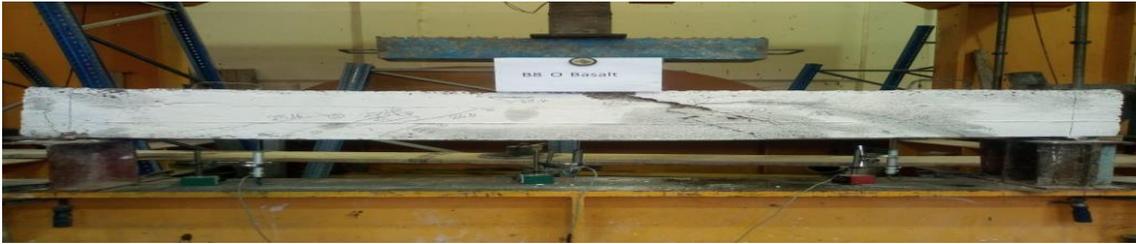
Cracks pattern for beams (B2OF) Cracks begin to occur with one flexural crack in the middle of beam (B2OF) otherwise the cracks is to start with one shear crack in the right of beam (B4OB).Number of cracks had done in beam (B2OF) is more than beam (B4OB).There is a different between two beams in shape of cracks at the end of loading at failure, beam (B2OF) had a large number of shear cracks in one side beam without symmetric shape along the span and it had a large number of flexural crack in the middle of the span but (B4OB) had asymmetric shape of shear cracks along the span and had just one flexural crack in mid span before failure load directly That means the flexural cracks delayed in appearance in basalt fibre beams with the presence of fibre in the beam because of the bridging action of the fibers and its role in controlling and carrying tension stresses induced in the flexure zone. The crack pattern for beams (B4OB ,B6OB and B8OB).begin to occur with one crack in the middle of beam1 with the first drop in strain bar reading otherwise the cracks is to start with one crack in the middle of beam3 but without drop in bar strain. Number of cracks had done in beam (B8OB) is more than beam (B4OB).There is a different between two beams in shape of cracks at the end of loading at failure, beaa(B4OB) had shape of on crack in the middle between two bows but beam(B8OB) had two cracks from the bottom connected to each other in the middle to be one crack at the end of the beam. The crack pattern for beams (B2OF and B10OF).begin to occur with two flexural cracks in the middle of beam then shear cracks started and widen and extend until connected from support to loading point surface and failure occurred suddenly. Number of cracks had done in beam (B10OF) is more than beam (B2OF).There is a different between two beams in shape of cracks at the end of loading at failure, beam (B2OF) had a large number of shear cracks in one side beam without symmetric shape along the span and it had a large number of flexural crack in the middle of the span but (B10OF) had asymmetric shape of shear cracks along the span and had a large number of flexural cracks and shear cracks in mid span during loading the beam. As shown in Fig. (14, 15, 16, 17 and 18).
