Study the Effect of Elevated Temperature on Reinforced concrete columns Strengthened Using Fibres

Eng. Saeed H. Elkorashy*, Prof.Dr. Mostafa Abdel Megied ** and Assoc.
Dr. Hala Mamdouh ***

This paper present a study on reinforced concrete strengthened with carbon and glass fibre to reduce the losses in concrete strength results from fire exposure, to gain more desired properties, confine the concrete members to sustain larger loads and to enhance or may convert the total behavior of the member into more ductile one and enhanced the character of concrete when exposed to fire. The behavior of reinforced concrete columns exposed to fire will be discussed with the addition of carbon and glass fibers by prepare 8 samples divided into two groups. The first group consists of two samples that were

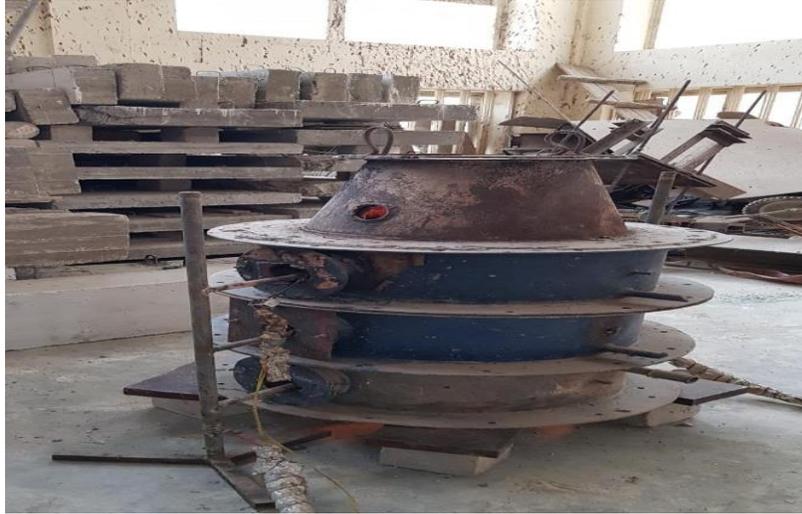
Fig. (2): An oven for burning samples.

Samples were placed inside oven at 400 c for two hours. Once asample has been burned, it is tested. As shown in Fig. 2. For concentric loading, steel plates were used to transfer the loads effectively to the desired regions through a calibrated vertical hydraulic jack 1500 kN capacity. Square load plates of size 250 x 250 mm to 40 mm thickness were used. The load was applied to each column in the form of a vertical concentrated load, under essentially pin-ended conditions with a constant rate of increase in increment of 5 kN where the deflection values were recorded. The load then continued up to failure. A special 3D steel frame setup for testing the columns was constructed (Mataria Faculty of Engineering, Helwan University). The setup consisted of the load cell to read the value of the load, Head to fix the specimen, and LVDT to measure vertical and horizontal displacement of the specimen during testing in material testing laboratory of the faculty of engineering Material Helwan University was used for testing. The frame consisted mainly of Horizontal I-beam fixed to two vertical columns I-beam by angles and bolts. The I-beam column was rested on floor. Two horizontal angles fixed at mid of column to Rest dial gage. The details of testing machine is shown in details Fig. 3.

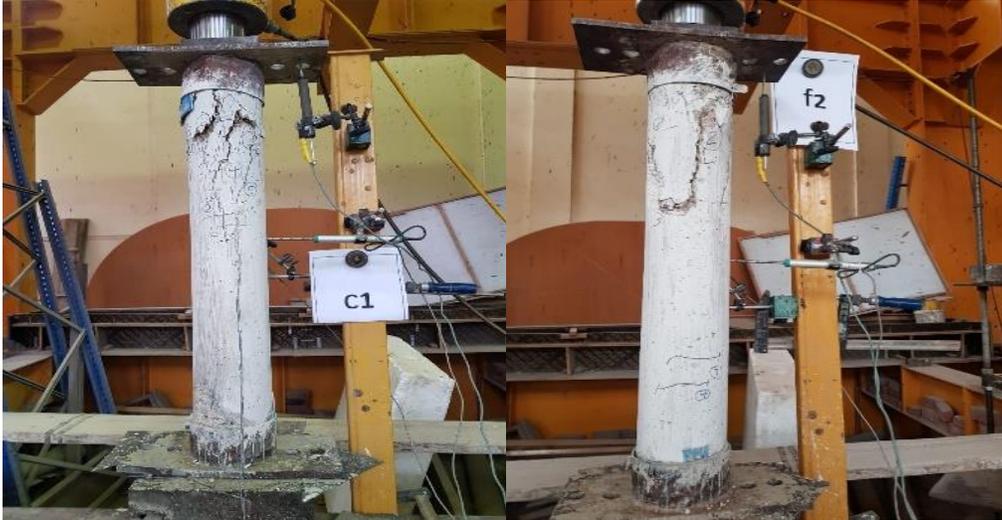
Fig. 3. Tested specimens of first group.

Fig. 3 and Fig. 4 shows cracking patterns for tested specimens, the failure load, maximum Axial and horizontal displacement for the entire tested columns are as shown In Table 3, from which the following observations are listed:

- First group consisted of two columns. In control columns (c1) not exposed to fire showed that the first crack appear at load level nearly 70% of column failure load. The

first crack appear at the top level of the column. Cracking pattern of tested column were generally vertical cracks, without inclination cracks as shown in Fig. 3. Control column (f2) exposed to fire showed that the first crack appear at load level nearly 60% of column failure load. The failure load is about 76% from the failure load of sample (c1), The first crack appear at the top level of the column, Cracking patterns of tested column were generally vertical cracks, with horizontal cracks at the bottom of the column. As shown in Fig. 3. Second group consisted of six columns: - column (GC3) not exposed to fire showed that the first crack appeared at load level nearly 96% of column failure load. The failure load improved from failure load of control sample (c1) by 7.6% The first crack appeared at the top quarter of The column, cracking patterns of tested column were generally vertical cracks, with horizontal crack appeared at failure load as shown in Fig. 4. Column (GC4) exposed to fire showed that the first crack appeared at load level nearly 98% of column failure load. The failure load was about 77% from the failure load of sample (GC3). The first crack appeared at the top level of the column, Cracking patterns of tested column were generally vertical cracks, without horizontal or inclined cracks. As shown in Fig. 4. Column (GC5) not exposed to fire showed that the first crack appear at load level nearly 89% of column failure load. The failure load improved from failure load of control sample (c1) by 11.7%. The first crack appear at the top level of the column, cracking patterns of tested column were generally vertical cracks, with horizontal cracks at top and bottom quarters of the column as shown in Fig. 4. Column (GC6) exposed to fire showed that the first crack appeared at load level nearly 90% of column failure load. The failure load was 80.5% from the failure load of sample (GC5), the first crack appeared at the top level of the column and Cracking patterns of tested column were generally vertical cracks at the top and bottom of the column, without horizontal cracks. As shown in Fig. 4. Column (GC7) not exposed to fire showed that the first crack appeared at load level nearly 87% of column failure load. . The failure load improved from failure load of control sample (c1) by 15.7%. the first crack appeared at the top level of the column, cracking patterns of tested column were generally vertical cracks, without horizontal cracks as shown in Fig. 4. Column (GC8) exposed to fire showed that the first crack appear at load level nearly 88% from column failure load. The failure load is 84% from the failure load of sample (GC7), the first crack appeared at the top level of the column and cracking patterns of tested column were generally vertical cracks at the top and bottom of the column, without horizontal or inclined cracks. As shown in Fig. 4.
