## Evaluation the Strength of one-way joist Concrete Slabs System by Load Test and Analysis the Causes of their Failure

Mohammad AbdulKader Al Zuhaili <sup>1</sup>, Ali Mohammed Al Tuhoo <sup>2</sup>

The main objective of in-situ testing is to evaluate the safety and serviceability of an existing structural system. This research describes the rationale and application of load test for *one way joist slab system*. The approaches are to determine the level of loading, loading procedures, hardware requirements, evaluation criteria and results for field projects. In addition to look for the possible causes for failure for this type of slabs. The case study was done for two concrete roof slabs on the first and second floors of a private villa is in *State of Kuwait*. There were observed weakness in the strength of concrete and deflection in the roofs and in addition, vibration and cracks appeared in some of slabs and beams. Therefore, it was necessary to check the structural safety of slabs and beams and look for causes of such failures.

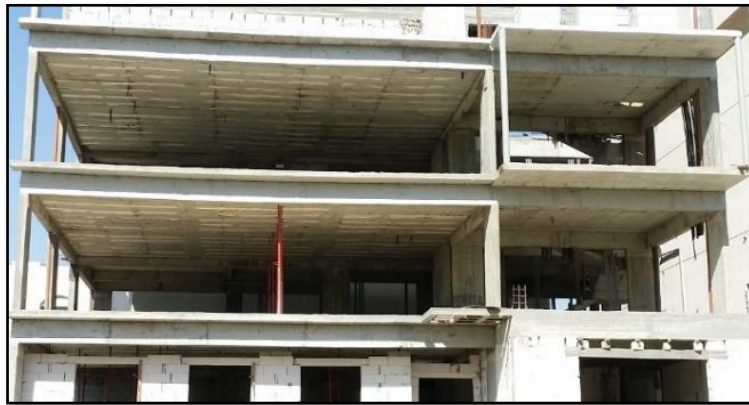
Fig. 1.Elevation of Building

Private villa was built in Kuwait city at 2016 (Fig. 1.) on an area of 400 square meters of land, consisting of four floors basement, ground, first and second, the building were built from Reinforced concrete.

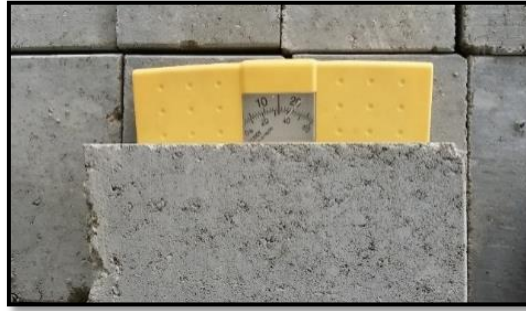
The design loads were simulated by means of concrete blocks (30\*20\*15 cm) (length x width x height) and sample weight equal 15 kg for each block are relatively easy to install and control. For the structure under investigation. And For this purpose, this load is exactly similar of finish and live load because is uniformly distribution on all area of slab equality.(Fig. 6) and since the load from the concrete blocks distributed like exactly real load, the effects of the design load is Similar to the load test. This give the very good response of the slab system and allowed using lighter equipment with low cost. the load test of slabs was done in phases.

**Fig.6** Weight of unit concrete block equal 15 kg/one

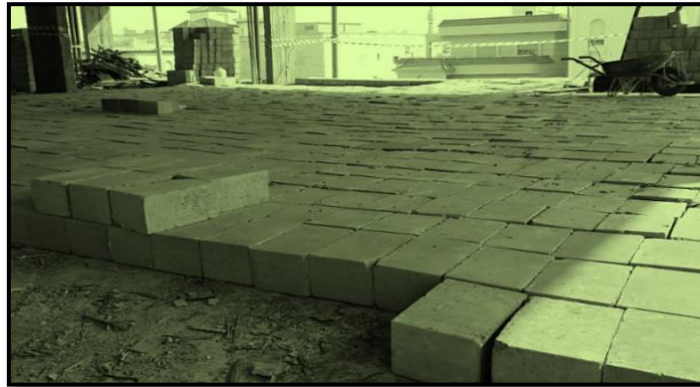
The load was applied at of slab uniformly distributed at all area as shown in (Fig.8)

The intensity of the applied load at was determined in three layers of blocks, and the total load of these three layers equals the exactly calculated test load so the same effect in terms of negative moment resulting from the factored, uniformly-distributed load

One Square meter contain 16.5 block \* 15 kg =  $247 \text{ kg / m}^2/\text{layer}$

$$\text{Three layers} \times 247 \text{ kg / m}^2 = 741 \text{ kg / m}^2 \# \underline{0.740 \text{ Ton/m}^2}$$

**Fig. 8.** Loading by Concrete Blocks uniformly distributed load

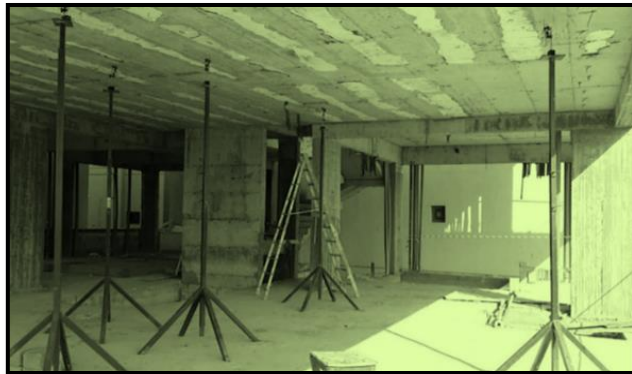
**Fig. 9.** Dial Gauges installation.in F.F.S

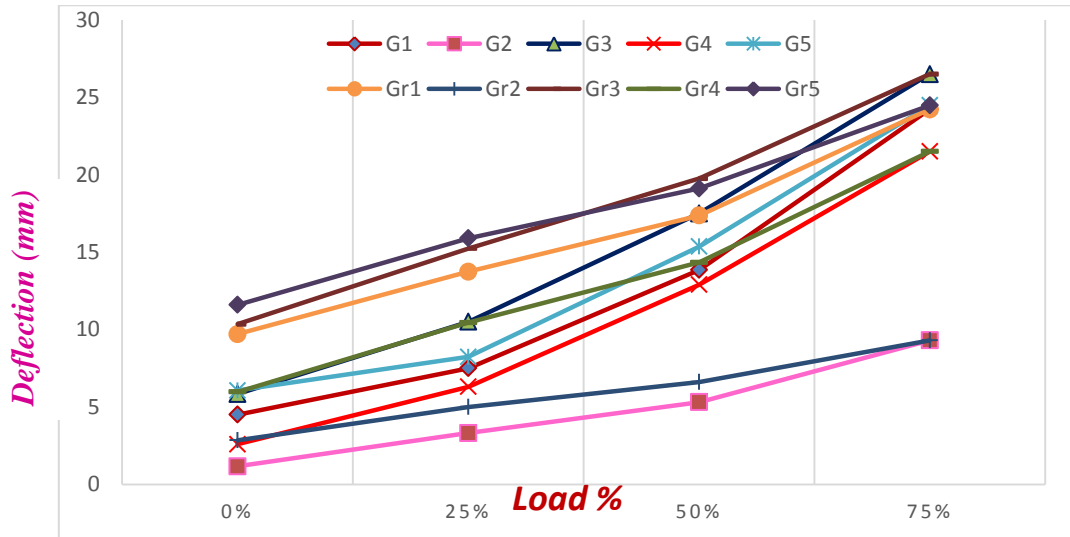
**Fig. 12:** Defl. (G), Rebound Defl. (Gr) and Max. Load Percentage for Dial Gauge  
Refer to table 1 it clear that gage no. *G1*, and *G5* Unverified

The graph, that is shown in (Fig. 12), show the relationships between the maximum deflection of the slab deflection for the dial gauge No.1 (G1) is 19.72 mm and the rebound deflection is to 5.20mm. For the dial gauge No.5 (G5), the maximum slab deflection is 18.41 mm and the rebound deflection is 5.35 mm as shown in (Fig. 13). From the load test results, all maximum deflections ( $\Delta_{max}$ ) from the testing must be less than the calculated deflection that is 11.025 mm. (calculated from Equation (2)) and the rebound deflections must be less than the calculated rebound deflections that are shown in the last column of Table 2 as well.

This slab has been suggested for demolition because maximum deflections is more than allowable as equation (2) (11.025 mm) also before applying all of the load many cracks were appeared

*“Structural member tested (First Floor Roof Slab) does not satisfy Criteria I or Criteria II”*

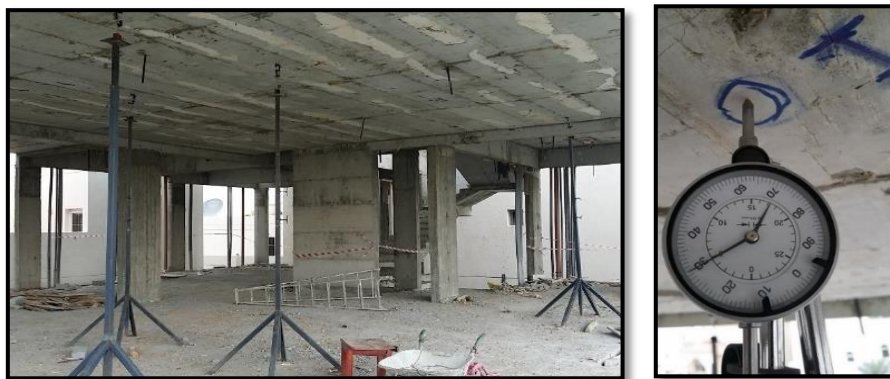
**Fig. 14:** Location of Dial Gauges.of S.F.R

**Fig. 15** Location of Dial Gauges on the plan of SFR

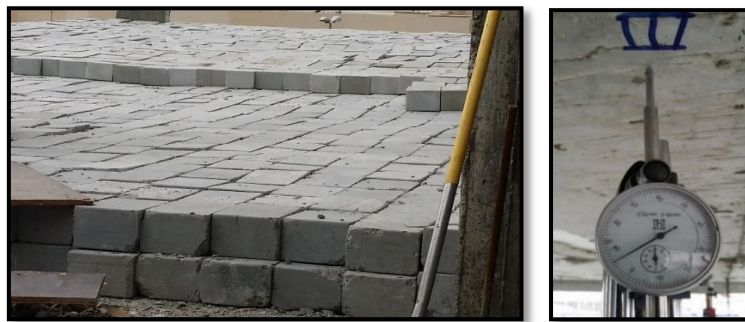
**Fig. 16:** Loading by Concrete Blocks uniformly distributed load

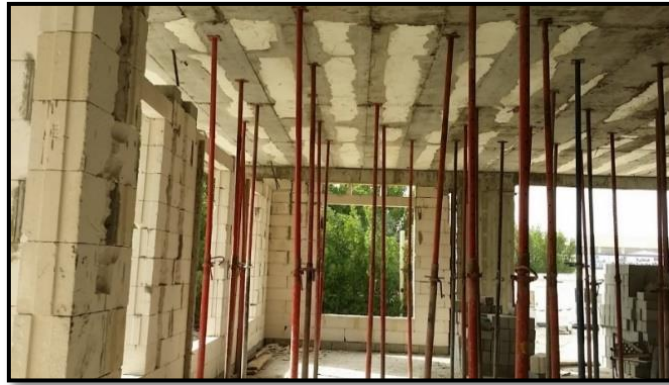
**Fig. 18.** Supporting the adjacent concrete slabs

The demolition and removal work was carried out. The slabs and adjacent concrete slabs were supported to ensure that the adjacent construction elements were not affected by the cracking and demolition process. (Fig. 18)

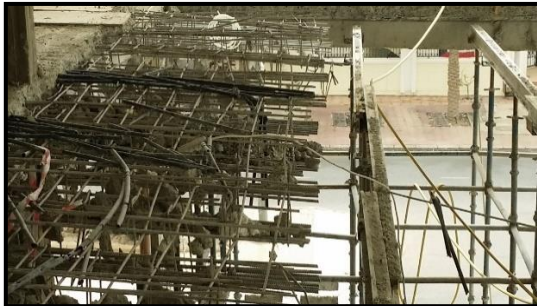
**Fig.19.** length of 1.30 meters

A plan has been made to cut the concrete of the slab, taking into account the distance of the surrounding slab, to remove it calmly and carefully, and to maintain the existing reinforcing steel to bond with the new reinforcement steel length of 1.30 m (Fig.19)

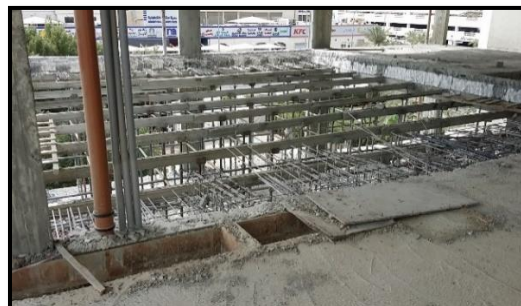
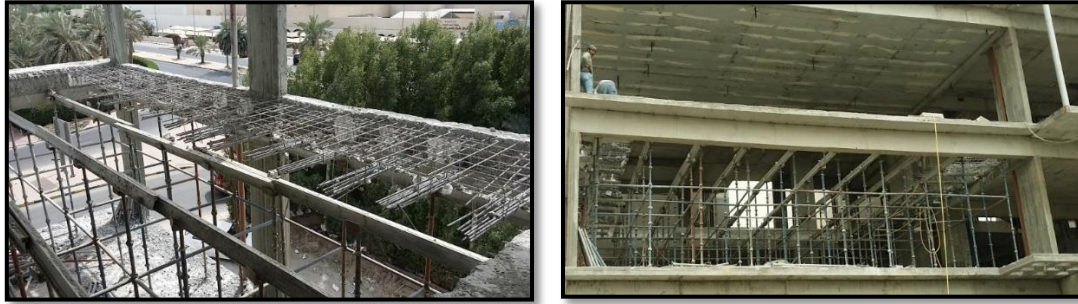
**Fig.20.** Reinforced concrete slabs after cutting

**Fig.22.** reinforced concrete slabs after cutting

Upon completion of the demolition and removal, important things were appeared:

1. Weakness of structural design carried out by the Engineering Consulting Office in terms of the dimensions of the rib section that do not comply with the ACI -318 requirements or international codes.
2. Defect in the implementation as the rib section of the performing and its dimensions do not match with the rib design section.

3. Bad distribution of ribs and space and distance between them, which are unequal
4. Change the thickness of the slab from place to another.
5. Contractor's Failure to apply the technical conditions and specifications for the execution of the concrete works for example there are gaps and empty spaces in the concrete
6. The strength of the reinforcement bars not tested.
7. as well as the concrete was not tested and may be weak because the results showed and during the cutting and removal is weakness in some places

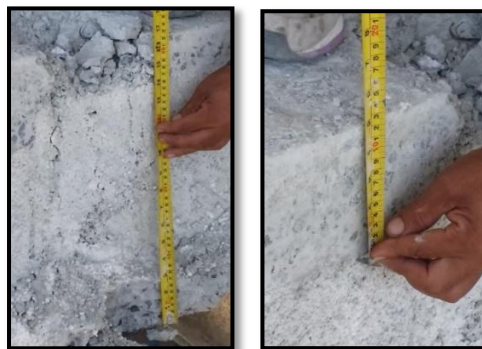
**Fig.21.**measuring of thickness of the rib and top slab
