Punching of Self Compacting High Strength Reinforced Concrete Flat Slabs at Edge Column Mohamed Youssef Mahmoud*, Ayman Hussein Khalil** and Mohamed Nabil***.

BAPETCO Structural Engineer*, Professor of RC structures, Ain shams University** and Assistant Professor of RC structures, Ain shams University***

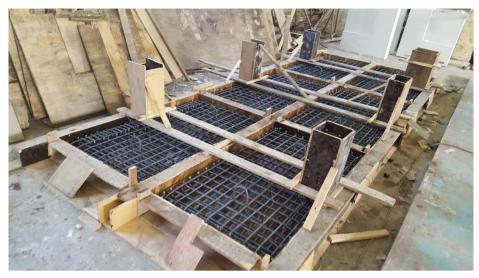
Fig.2: formwork and steel rebar

All the formwork, steel rebar, concrete casting and curing were performed in the concrete laboratory at structural engineering department of Ain Shams University. The concrete were mixed using blender mixer while the curing was through water and the specimens were covered with burlap with continuous watering as in figures 2 to 5.

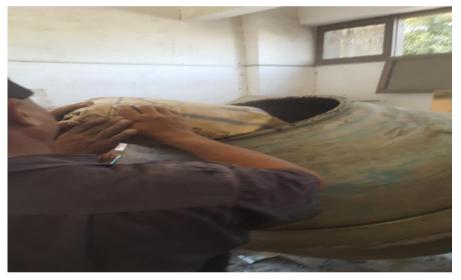
Fig.3: mixing materials

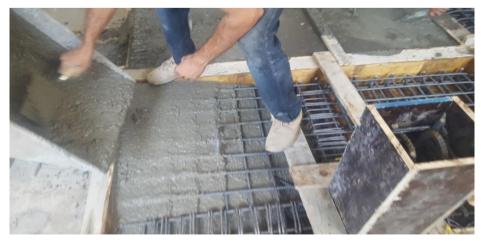
Fig.4: casting of specimen

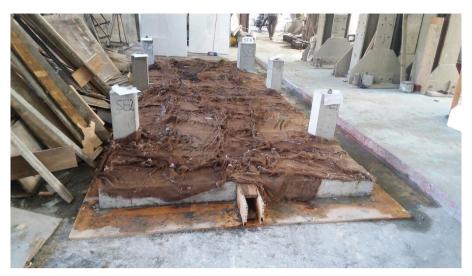
Fig.5: specimen curing by covering with wet burlap

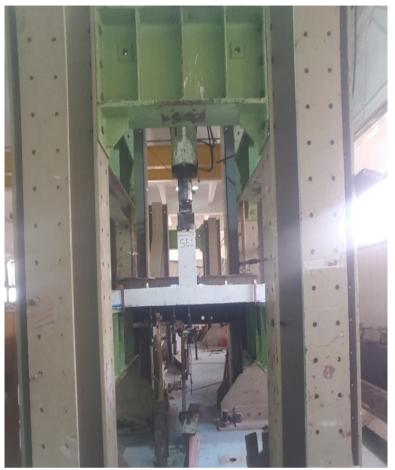
Fig.9: Test set-up for specimens

The connections were tested in an upside-down position with respect to the position of a real structure. This was done due to the test setup available in the laboratory which allows the vertical shearing force to be applied from top to bottom. Therefore, tension cracks appeared at the bottom side of the slabs. The loading steel frame used to support the slabs consists of four steel I-beams sections installed on four columns. The slabs were simply supported on heavy steel I-beam arrangement along three of the four edges while the fourth edge where the column exists was left free. To ensure full contact between the specimen surface and the supporting steel beams a rubber mat of 1 cm thickness and 10 cm width was used underneath the slab edge. The specimens were prevented from uplift by using upper supporting frame. The load had been applied vertically using hydraulic jack with 1000 Kn capacity acting at the centre of the column. A steel plate was installed underneath the hydraulic jack to uniformly transfer the applied load to the upper surface of the column and to ensure full contact with the column. The hydraulic jack was hanging from the standard I-beam steel section. Hanging the hydraulic jacks from the I-beam section ensured the verticality of the jack during all steps of the test. The I-beam is very rigid to not exhibit any deformation under the applied actuator load. Test set-up shown in figure 9.

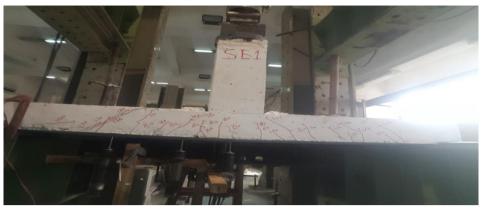
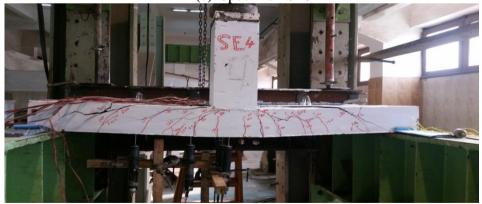
(a) Specimen SE1

(b) Specimen SE2

(c) Specimen SE3

(d) Specimen SE4 **Fig.10**: Crack pattern and failure mode for Specimens SE1, SE2, SE3 and SE4.

The four connections failed in a brittle punching shear mode with no signs of flexural failure, concrete crushing at the compression face of the slab. The failure was characterized by a severe drop in the vertical load when the column along with a conical portion of the slab punched through the remainder of the slab as going to be shown below. However the four connections failed in brittle punching shear mode, they have showed slight differences in the cracking pattern. it was obvious that the crack patterns for all specimens were similar at early stage of loading as the first crack was on the tension side of the slab and mainly below the column and the first crack appeared for the six specimens at close loads, while the significant difference was noted closer to their failure load as diagonal cracks appeared during loading and the first cracks became wider till punching shear cone failure appeared as shown in figure 10.
