## Behavior of Polymer Concrete Beams Reinforced with Polymer-Based Fiber Bars

**ABSTRACT:** The primary objective of this study was to evaluate the effect of fiber reinforcement bars with different development length on the behavior of polymer concrete beams. This research focused on comparing the failure modes of beams with different development lengths, types of reinforcement, and investigating the effect of adding polymers to concrete. GFRP bars were made by using a simple pultrusion process, ensuring that the fiber density was not less than 65% of the size of one bar to provide higher tensile stress. The behavior of specimens was studied under flexural failure. The first phase involved studying the behavior of GFRP bars reinforcement with conventional concrete beams with different development lengths (full bars, 200mm, 100mm, zero), the second phase involved steel bars reinforcement with polymer concrete beams, and the third phase involved GFRP bars reinforcement with polymer concrete beams with the same development lengths. Test results show that the use of GFRP bars reinforcement with polymer concrete increased the capacity of beams. Moreover, it led to benefiting from the

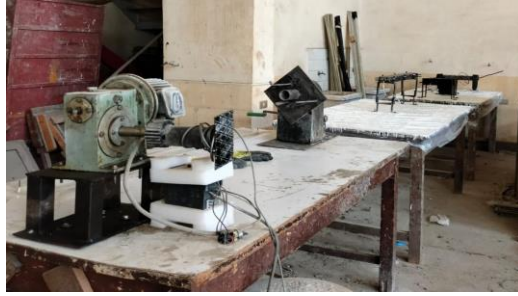
Figure 2.1: Pultrusion Process

The mechanical properties (i.e., tensile load, modulus of elasticity and stress-strain relationship) were evaluated in the first phase. GFRP bars were made by making a simple pultrusion process as shown in figure (2.1) and (2.2). These bars were used for the main reinforcement of all the beams in groups 1 and 3. Tests were made for 3 samples of GFRB bars manufactured, with 1.0-meter-long and 10mm diameter to know their properties. The manufacturing process involves several steps:

1. Prepare the quantity of fiber yarns needed to make a bar with a 10 mm diameter, ensuring that the density of the fiber is not less than 65% of the size of one bar.
2. Immerse the fiber yarns in a bath of polyester resin with a suitable amount of hardener.
3. Insert the fiber yarns into the die with a diameter equal to the required final diameter (10 mm) while keeping the bar pulled during this process.
4. Create fiber protrusions on the bar's surface to achieve the final shape, using the same material as the bars. Ensure that the fiberglass yarns are well submerged in polyester resin.
5. Leave the bars in the air for enough time to reach the final hardening point.

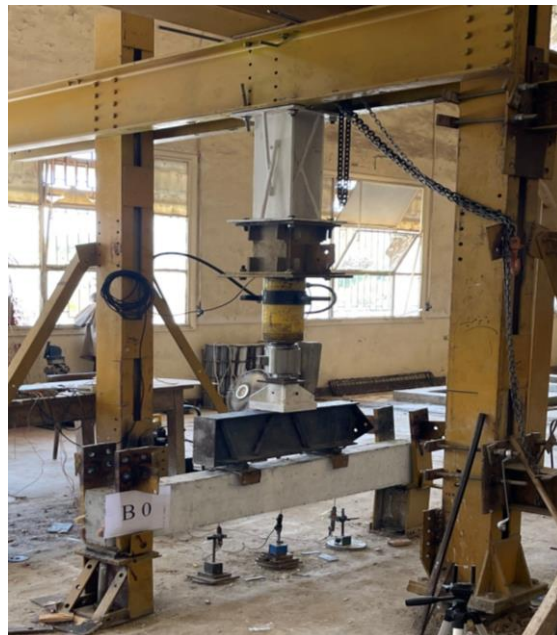
Figure 2.3: Testing Frame

In the second phase of the current experimental program, one control beam and three groups consisting of twelve beams. All beams had a cross section 120 mm x 250 mm. The beams were simply supported with a clear span of 1800 mm with the existence of some variables. Control beam B0 with conventional concrete reinforced with steel bars. Group 1 consisted of four beams: B11, B12, B13 and B14 with conventional concrete reinforced with GFRP bars. Group 2 consisted of four beams: B21, B22, B23 and B24 with polymer concrete reinforced with steel bars. Group 3 consisted of four beams: B31, B32, B33 and B34 with polymer concrete reinforced with GFRP bars. The specific parameter of each specimen is described in Table (2.1). A significant feature of the RC beams was that their shear capacity exceeded their flexural capacity. The flexural failure mode of beams was ensured by this design. Furthermore, a testing machine with one hydraulic jack was used with capacity 250 kN (Figure 2.3). Through the actuator, loads were monotonically applied.

The test beams were mounted on the frame and adjusted on the supports. Two concentrated loads were applied. The spacing between the two loads was 600mm, and each load was at a distance of 300mm from the midpoint of the span. The displacement of the beams was carried out at three points; one at the midspan zone and the other two at a distance of 300mm from the midpoint of the span. It was monitored by three LVDTs, and load cell. Strain data were recorded using a data logger. An additional strain gauge, fastened to the reinforcing surface, was used to track the longitudinal tension bars. Using a small grinder, the rebar was flattened and sanded to ensure that the strain gauges adhered properly to the steel.

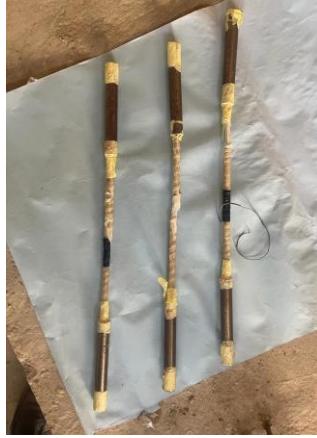
Figure 3.1: Failure of The Samples

After testing the samples, the failure points of the samples were in the middle, as shown in **Figure (3.1)**. The failure loads for the three samples were 83.74 kN, 75.7 kN and 78.123 kN, respectively. The stress-strain relationship of the GFRP bars was linearly elastic up to failure. The ultimate stress of the GFRP bars were 1066 MPa, 964 MPa and 995 MPa respectively. The GFRP bars modulus of elasticity were 54553 MPa, 54506 MPa and 54302 MPa respectively, according to the samples test results as shown in **Figure (3.2)**. Average of the ultimate stress and modulus of elasticity for the GFRP bars were 1000 MPa and 54450 MPa respectively, according to the samples test results. The dimeters of the GFRP bars were 10 mm, as shown in **Table (3.1)** and **Figure (3.3)**.

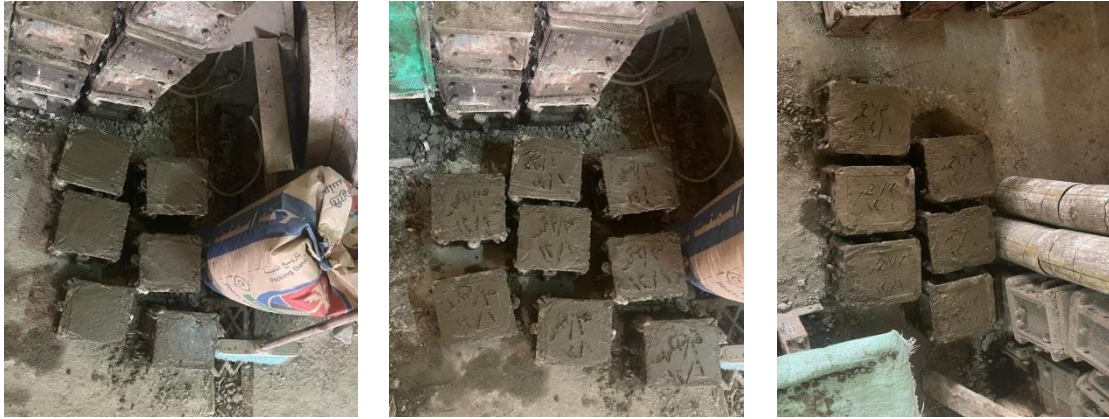
Figure 3.4: standard cubes of The Samples

Thirteen standard cubes, 150x150x150 mm and 100x100x100 mm, were taken from the concrete at regular intervals during casting of the girders as shown in Figure (3.4). These control specimens were cast, compacted, and cured simultaneously with each tested specimen, and they were tested at the same time as the beams. The results of the cube testing are presented in **Table (3.2)** and **Figure (3.5)**. Failure load of the tested beams was conducted. The failure loads were compared with the type of reinforcement and development length for all beams. For the control beam, the following results were observed: cracks appeared at midspan of the beam at 10 kN. The cracks increased progressively with the increase of loads, and failure occurred at 101 kN due to yielding of the steel. **Figures (3.6)** show the failure mode and crack pattern of the control beam.

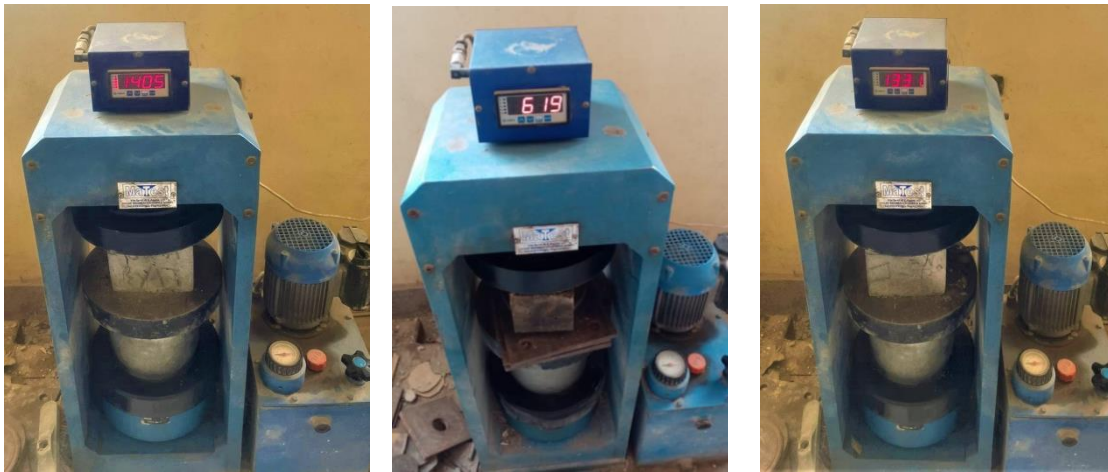
Figure

3.5: Failure of The Samples

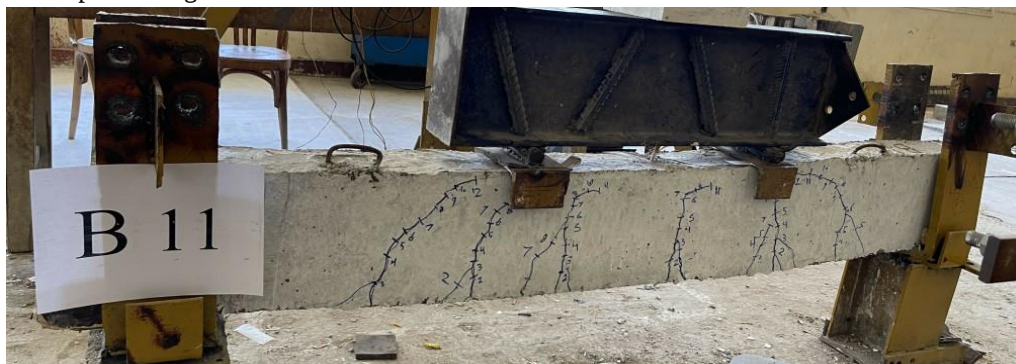
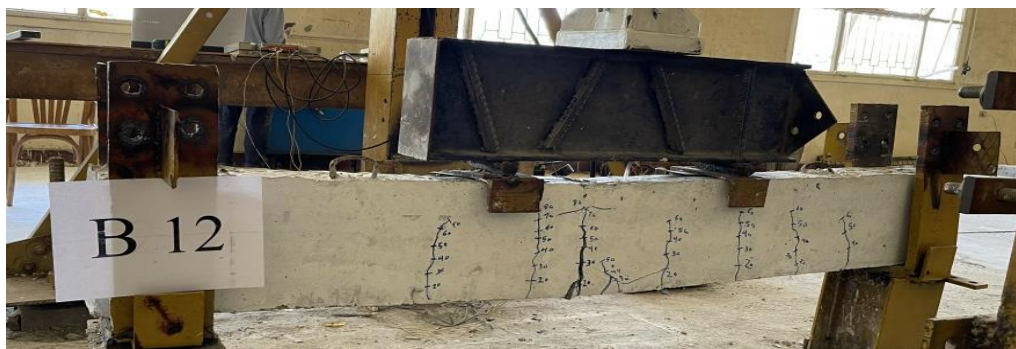
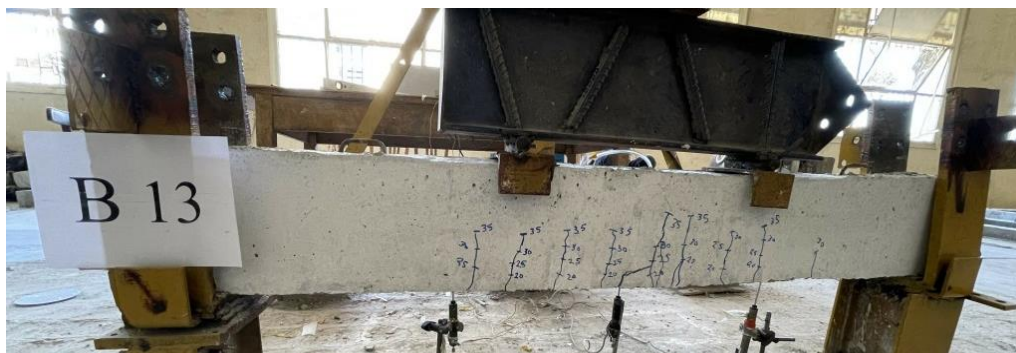
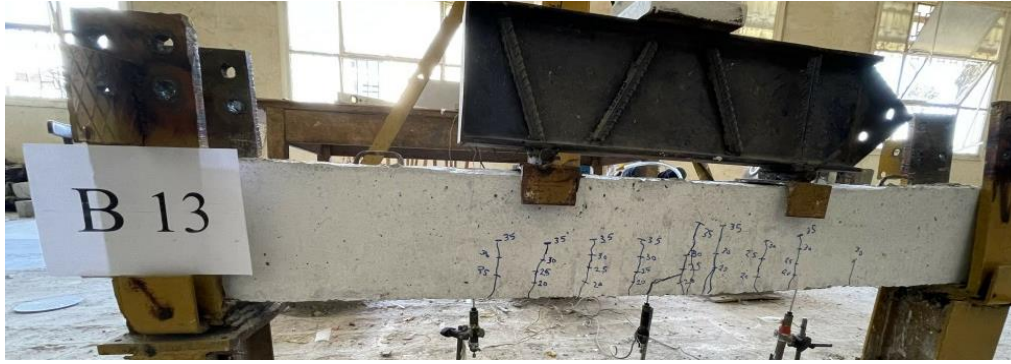
Figure 3.7: Failure mode and crack Pattern of Group 1-Conventional concrete beam reinforced with GFRP bars with different development lengths

In this group, the effect of reinforced conventional concrete beams by GFRP bars with different development lengths was investigated. For B11, GFRP full bars; the cracks appeared at 10 kN. The failure occurred at 123 kN due to rupture of GFRP bars.

For B12, GFRP bars with development length = 200 mm; the cracks appeared at 10 kN. The cracks increased normally with the increase of loads. The failure occurred at 59 kN due to slipping of GFRP bars from concrete.

For B13, GFRP bars with development length=100 mm; the cracks appeared at 10 kN. The cracks increased normally. The failure occurred at 34 kN due to slipping of GFRP bars from concrete.

For B14, GFRP bars with development length=zero; The cracks appeared at 10 kN. The cracks did not increase because the failure load was nearby, but the width of the cracks increased. The failure occurred at 16 kN due to failure of concrete at midpoint between of bars. **Figure (3.7)** shows the failure mode and crack pattern of group1.

- The reinforcement of GFRP bars in the conventional concrete caused increase in the capacity of beams.
- GFRP bars have a negligible bond with conventional concrete.
- In beam B14, it is evident that the capacity is small due to the weak bond between the concrete and the reinforcement to transfer the force between the bars at the point of contact, putting into consideration that the development length is zero.

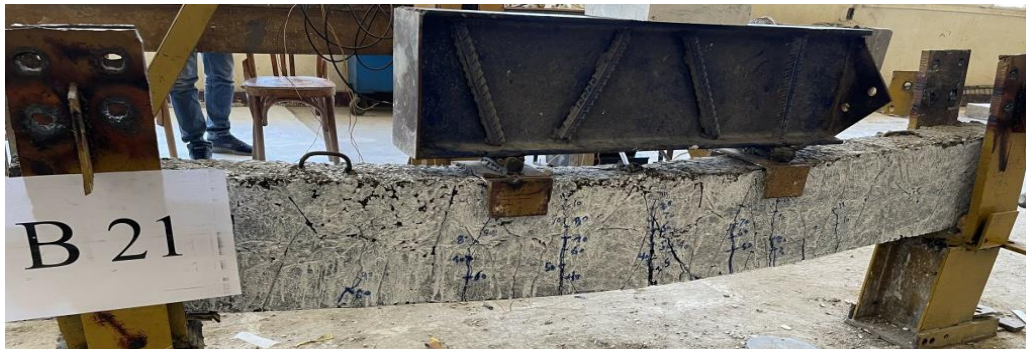
**Figure 3.8:** Failure mode and crack Pattern of Group 2- Polymer concrete beams reinforced by steel with different development lengths

In this group the effect of reinforced polymer concrete beams by steel with different development lengths was investigated. For B21, steel full bars; the cracks appeared at 15 kN. The cracks increased normally with the increase of loads. The failure occurred at 123 kN due to yielding of steel.

For B22, steel bars with development length = 200 mm; the cracks appeared at 15 kN. The failure occurred at 93 kN due to slipping of steel bars from concrete.

For B23, steel bars with development length = 100 mm; the cracks appeared at 15 kN. The failure occurred at 51 kN due to slipping of steel bars from concrete.

For B24, steel bars with development length = zero; the cracks appeared at 15 kN. The cracks did not increased because the failure load was nearby, but the width of cracks increased. The failure occurred at 24 kN due to failure of concrete at midpoint between of bars. Figure (3.8) shows the failure mode and crack pattern of group2.

- The polymer concrete caused increase in the capacity of beams.
- Steel bars have a good bond with the polymer concrete.
- In beam B24, it is evident that the capacity is small due to the weak bond between the polymer concrete and the reinforcement to transfer the force between the bars at the point of contact. putting into consideration the development length is zero.
